# Celtic Explorer - Generating Engine Alignment Problems

John Breslin

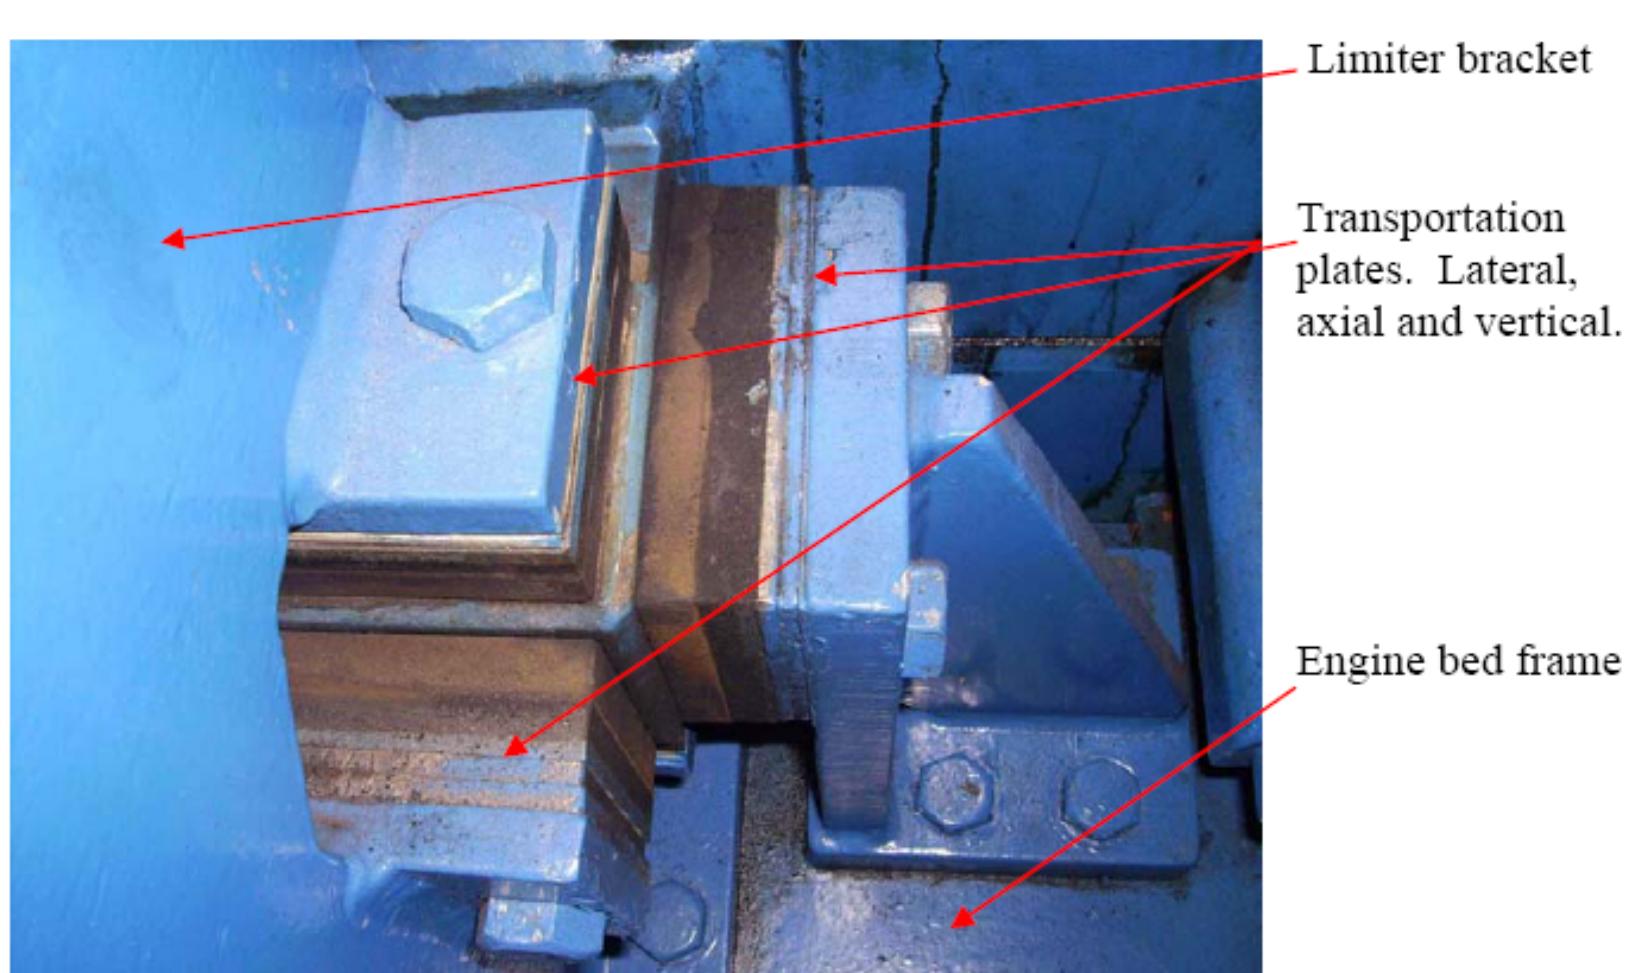
- The photograph below shows an engine limiter of which there are two fitted to each side of each engine.

- Transportation plates hold the engine rigidly for transportation purposes and should be removed when fitting into the vessel to give a limiter clearance of 6 mm. Thus the engines rest on the resilient mounts and are free to move within the specified clearances.
- The above photograph is of one limiter on the "Celtic Explorer" and clearly indicates the lack of any clearance due to the transportation plates being still in place and which are effectively holding the engine in a rigid position, vertically, axially and laterally.
- The above condition was common to all limiters on all three generating engines.

- Wartsila Installation procedure advises that additional distance plates are installed behind the rubber elements in the limiters for transportation. Remove the additional distance plates and adjust all clearances to 6 mm. The clearance is adjusted by adding or removing distance plates of different thickness, delivered in 1 mm, 5 mm and 6 mm thicknesses.

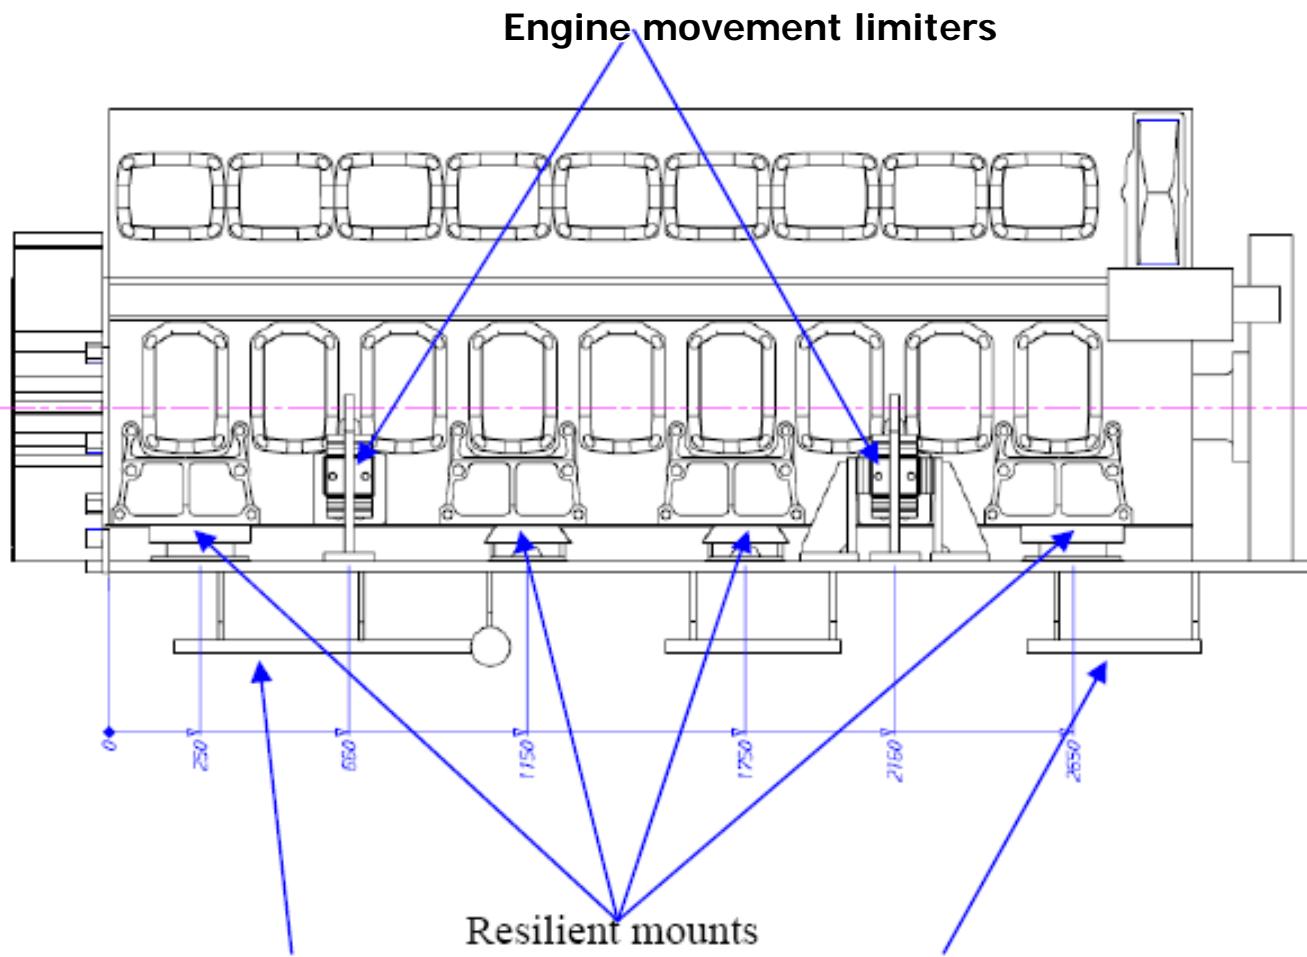
- The drawing below is a side elevation showing the resilient mounts and limiters.

Resilient mounts are also fitted beneath the base frame which not shown

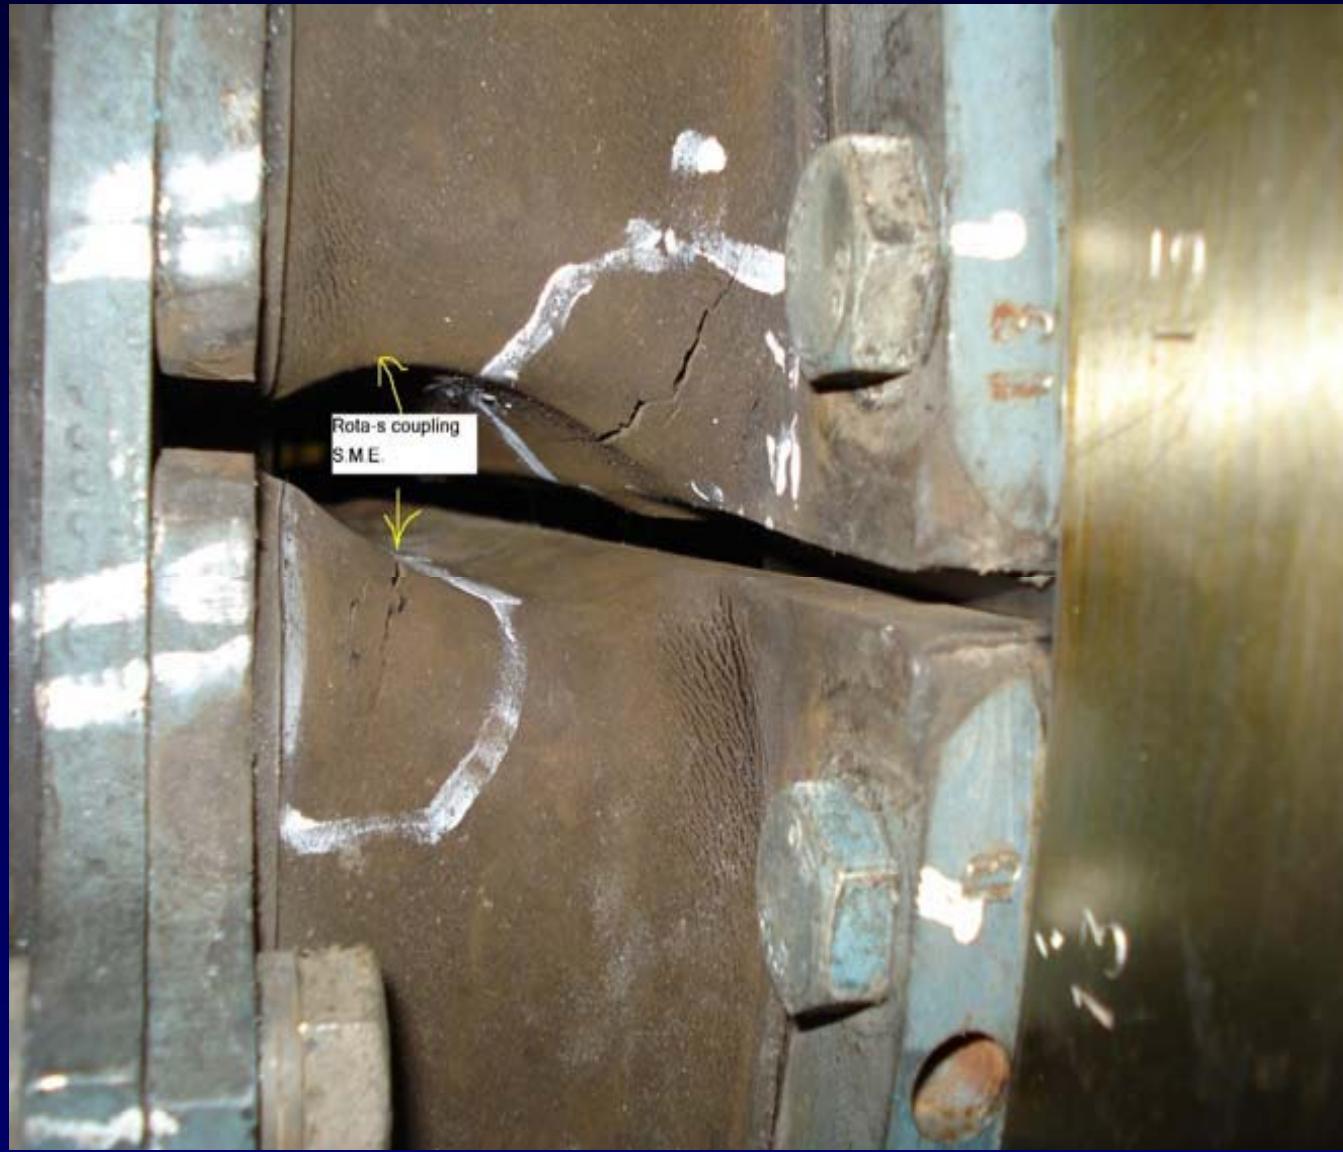
The photograph below shows the Vulkan coupling rubber element taken from the starboard engine which has suffered fatigue and ultimate cracking due to abnormal operating conditions. The port engine coupling also suffered from fatigue and cracking to a lesser extent.

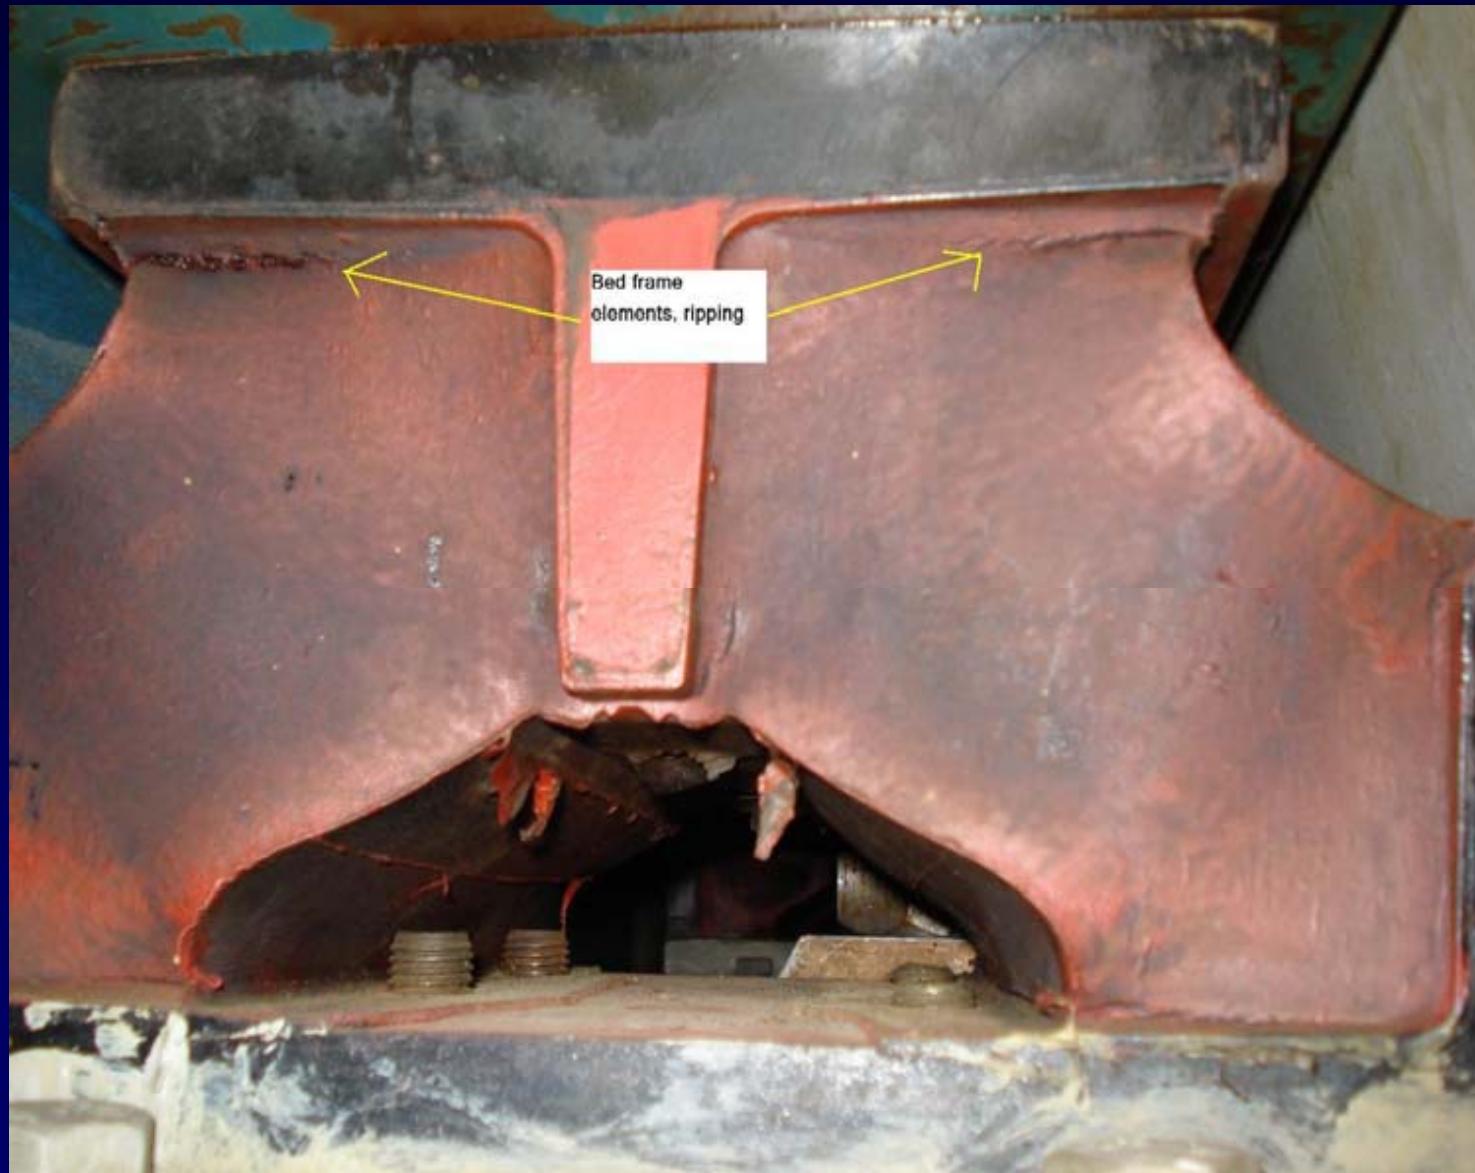
The photograph below is of a bedplate mounting Metalistic series super 'D' flexi-mount which clearly shows fracturing at the ends caused by abnormal high stress due to an incorrect working environment.

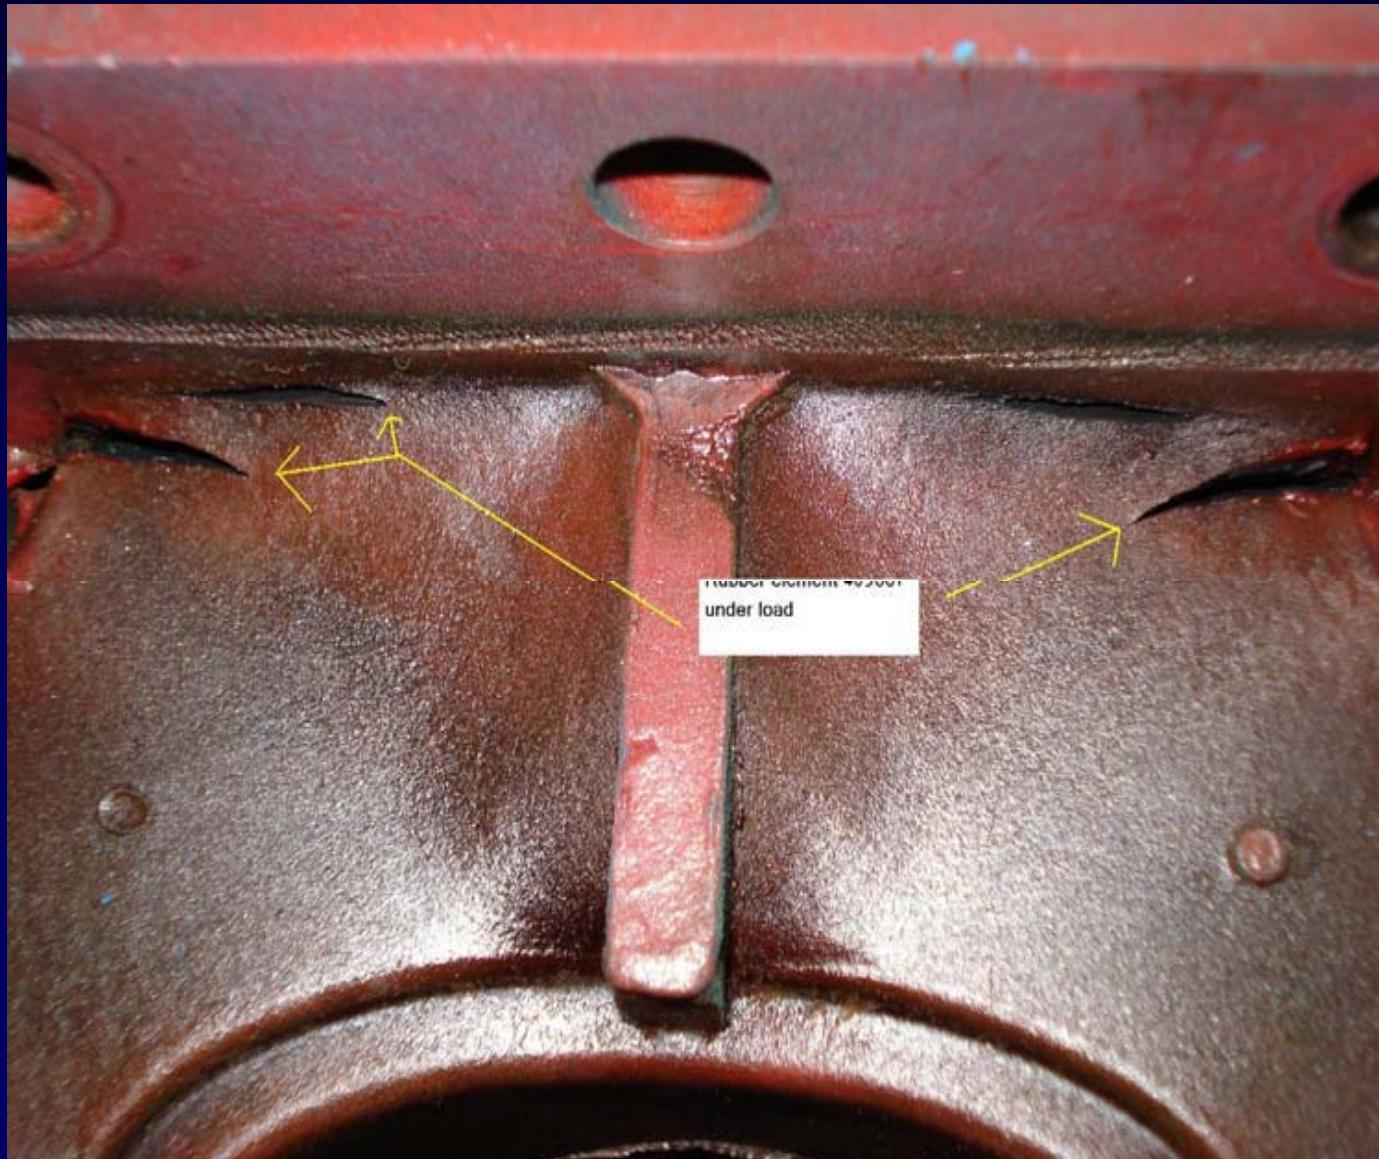
This next photograph is of an engine mounting metalistic series 'D' flexi-mount showing tearing of the rubber under load. Condition of all super 'D' and 'D' types was found on the occasion of previous survey to be similar and obviously requiring renewal.

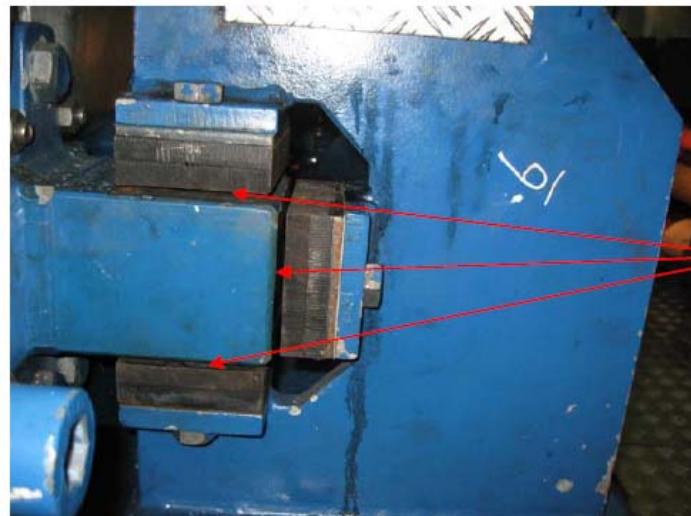
The photograph below show one engine limiter. Following removal of transportation plates, the 6 mm clearance can be clearly seen in all planes.

Height and side clearances.

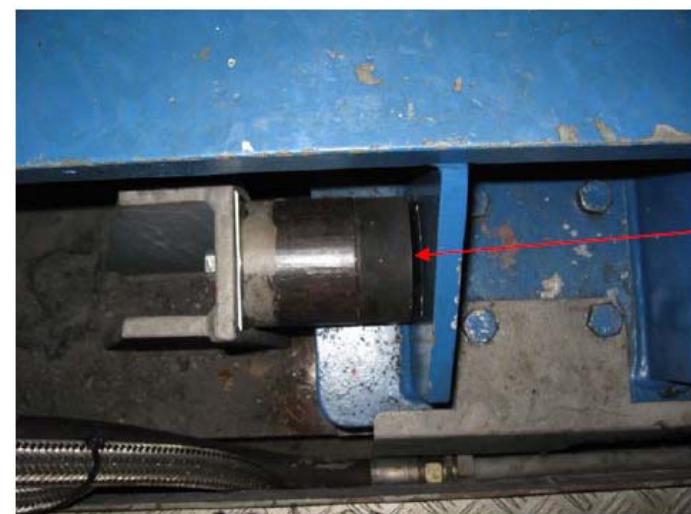
Longitudinal clearance
