RV Odon De Buen: Sea trials in Antarctica

MAIN (PLATFORM TESTING)

TEST ATLANTIC NAVIGATION CONDITIONS

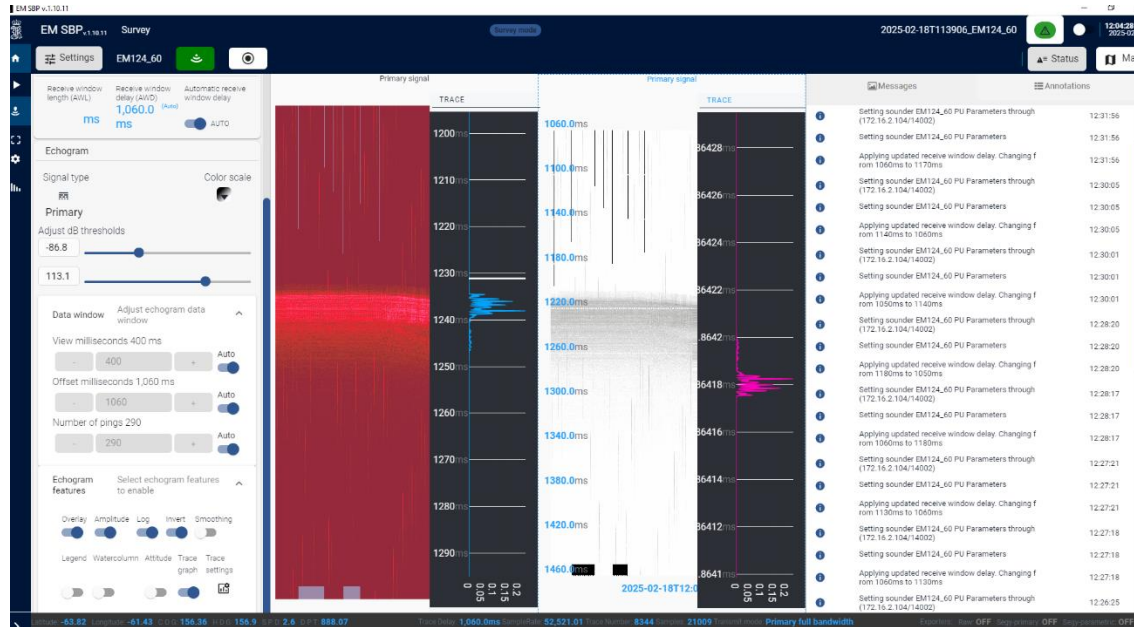
The primary frequency was successfully adjusted, but it was not possible to obtain a quality echogram with the parametric system, as neither the seafloor nor the processed signal could be detected.

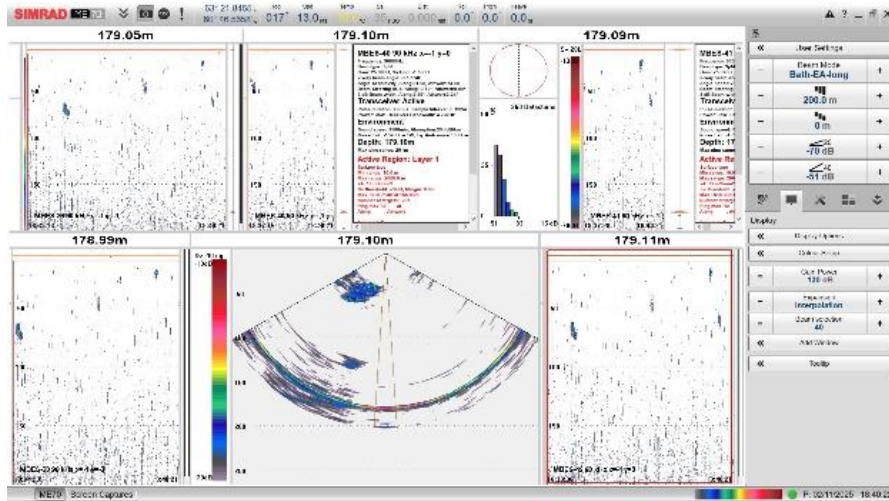
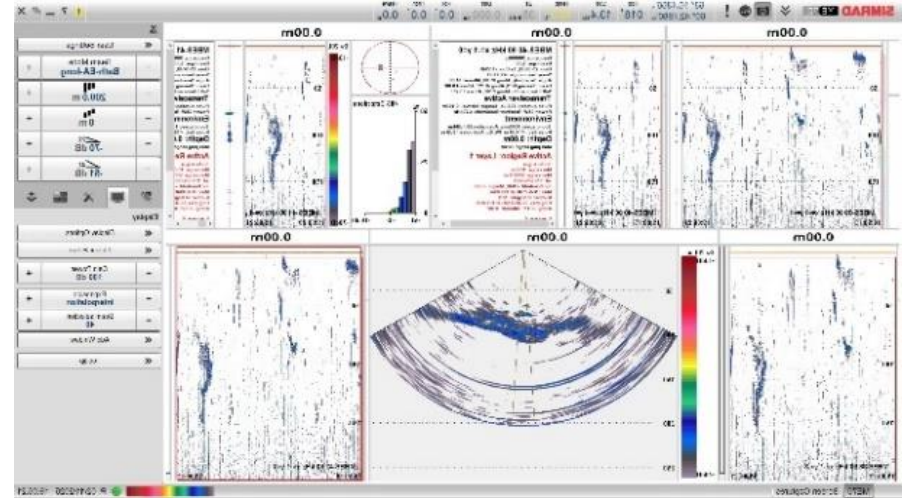
- A radiated noise test was conducted at a depth of between 150 and 250 m, with both keels flush and unfurled.
- Preliminary results (direct readings) from the noise tests revealed inconsistencies, especially at 18 and 38 kHz, indicating the need for specific noise tests and calibration of the various transducers.
- The noise detected by the EK80 at 18 and 38 kHz disappeared when the EA640 stops transmitting at 12 kHz.
