Multibeam Upgrade RV Celtic Voyager
17th ERVO Meeting
11th June 2015

Aodhán FitzGerald
Research Vessel Manager
Marine Institute

Celtic Voyager Geophysical /Hydrographic systems and status

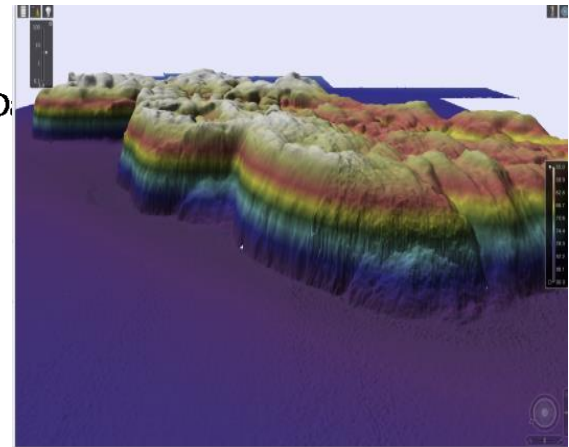
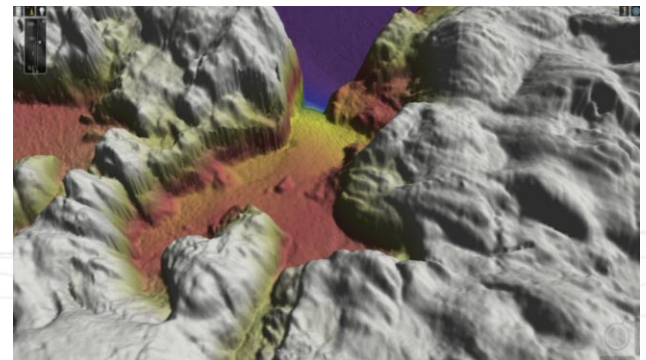
Teelin Knowl 2040 D.

Initial trials very successful...
But... PU problems in shallow water occurred and data drop out when steaming at over 4 knots.....

PU problem solved eventually by replacement with new "slim pu's)
Data drop out due to cable connections making and breaking as cables not secured correctly with plastic brackets

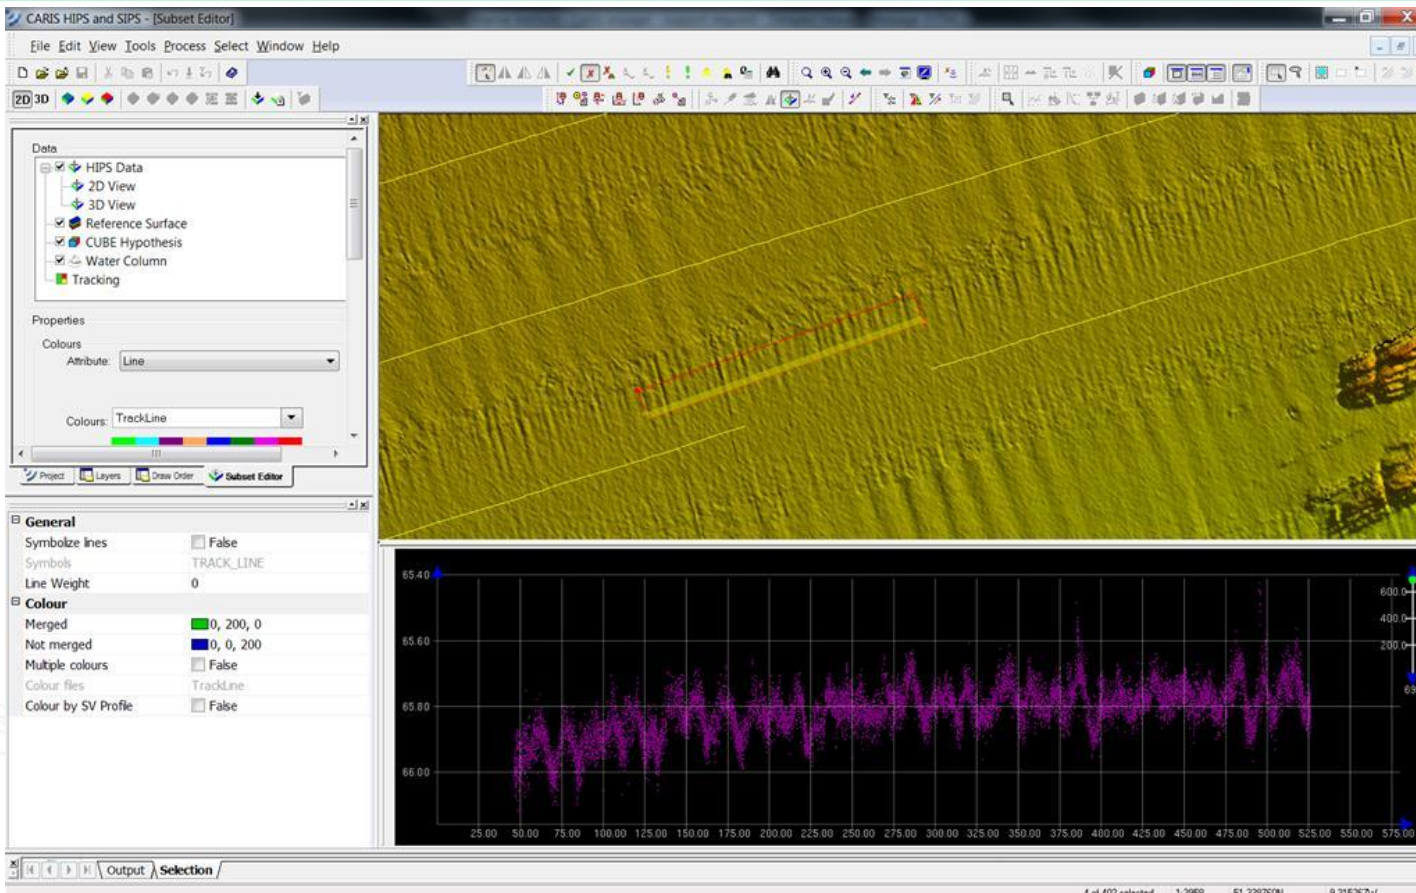
Outer Beam wobble....
Attributed to rapidly
changing SV as vessel
pitches.... In water
column with rapidly
changing SV profile
