IMR new costal vessel update from first months of testing and operation

Main ship data (sorry for the Norwegian text)

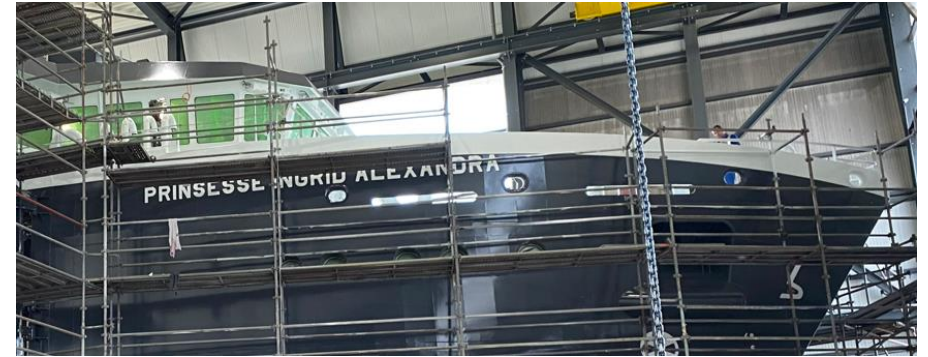
HOVEDDIMENSJONER

LENGDE OVER ALT	35.0
LENGDE MELLOM PERPENDIKULÆRER	32.2
BREDDE PÅ SPANT	10.0
DYBDE I RISS	4.6
MAKS DYPGANG	3.5
SPANTAVSTAND	0.5

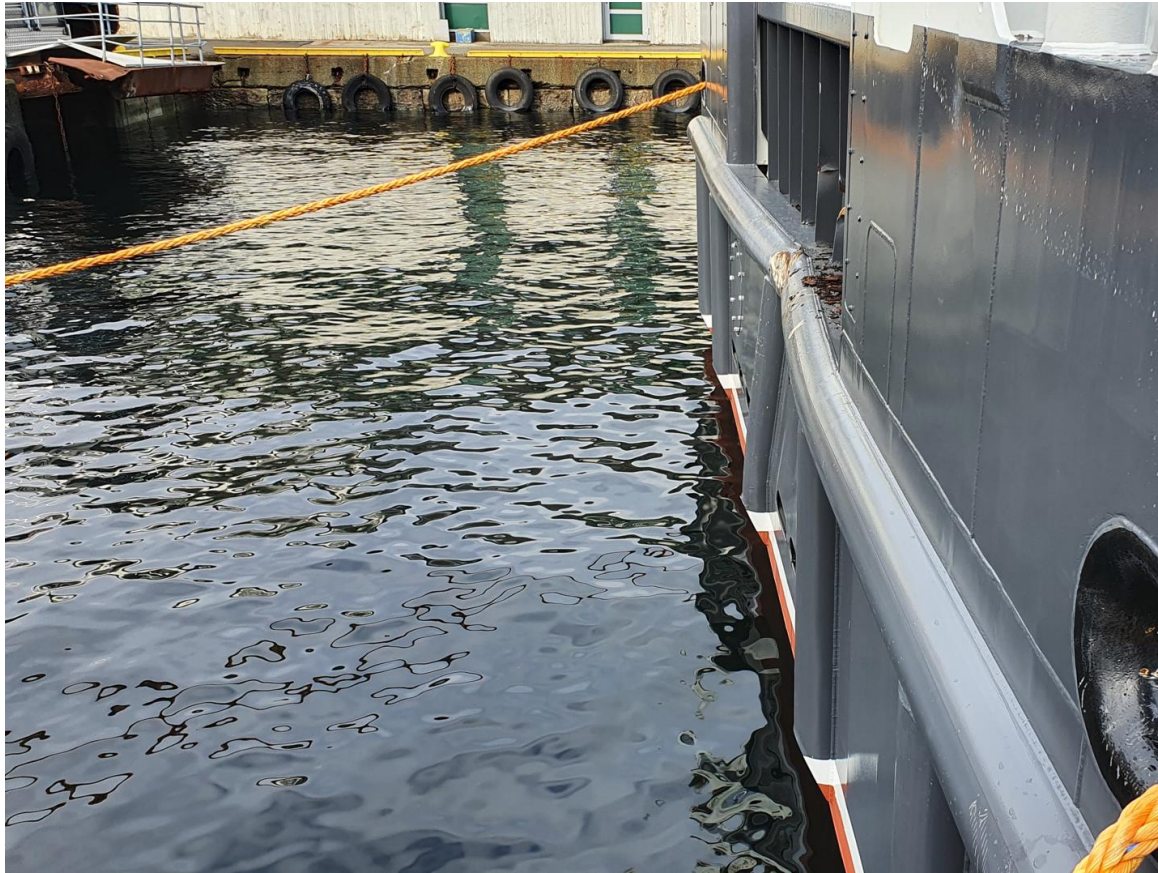
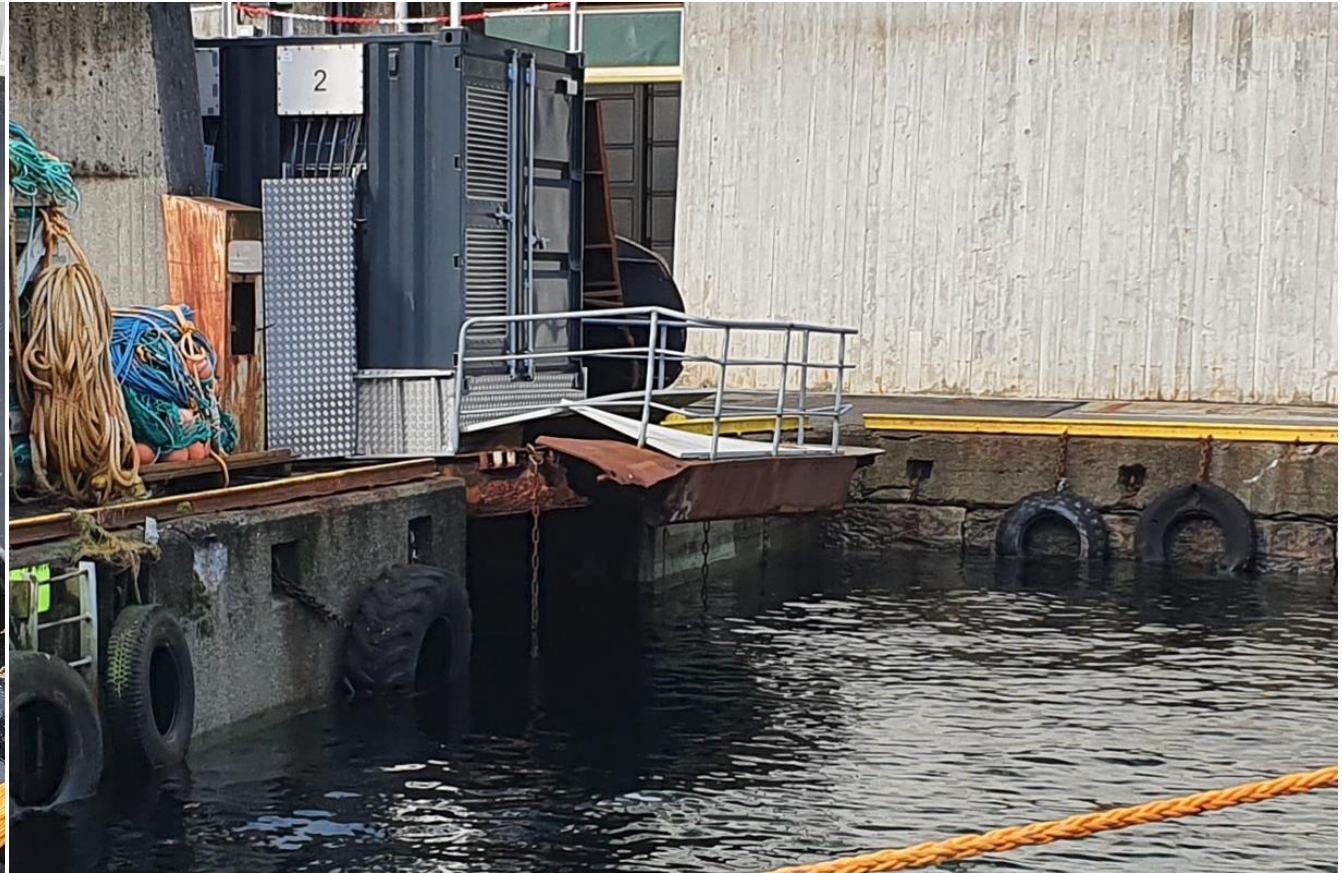
- Engine control failure
- High noise for gear box or ? , when operation in PTI and PTO mode.

Damage during maneuvering in port

Engine control failure

The control failure might be an EMC challenge. The yard had some challenges with the electrical installation on which standard to follow, and our specification and follow up on EMC might need to be improved. We have had a few other issues within the same topic. One was use of a hand held UHF close to the CTD control computer released two CTD bottles. This is something we will focus on for coming upgrades and newbuilds. In particular for small vessels where it is very difficult to separate different types of cables.
