R/V *Celtic Voyager*, engine failure 2015 - Lessons learnt

ERVO Annual Meeting - May 10-12, 2016
HCMR, Rhodes

Celtic Voyager engine failure 2015

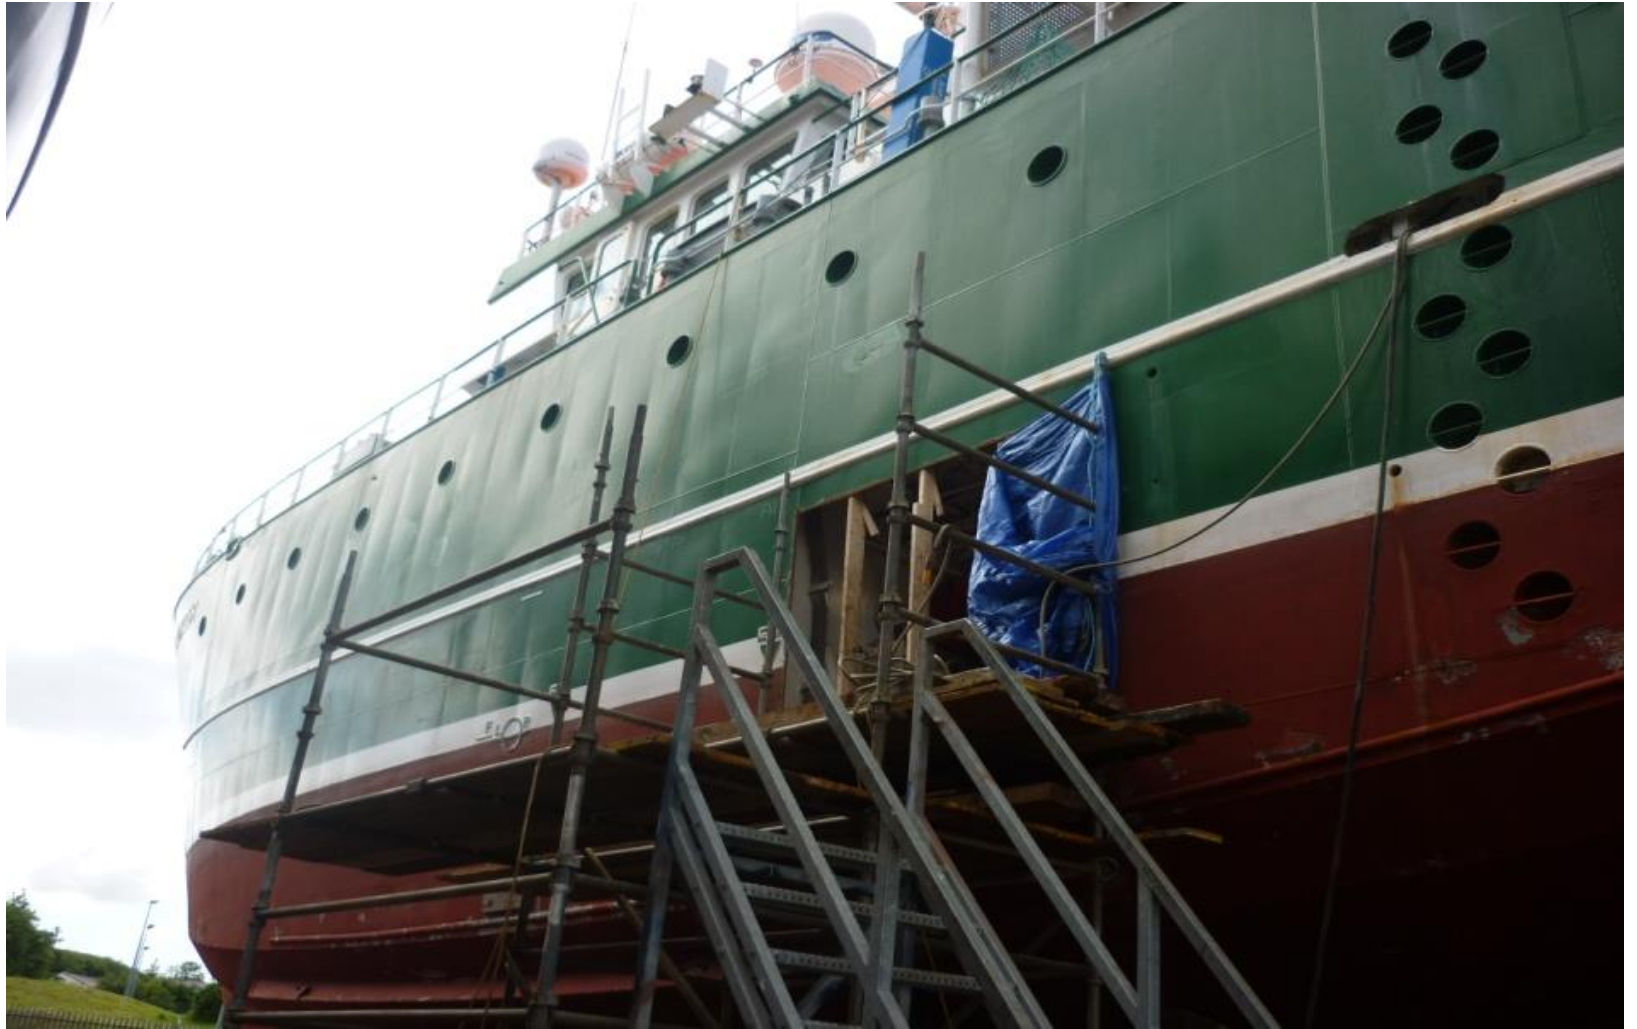
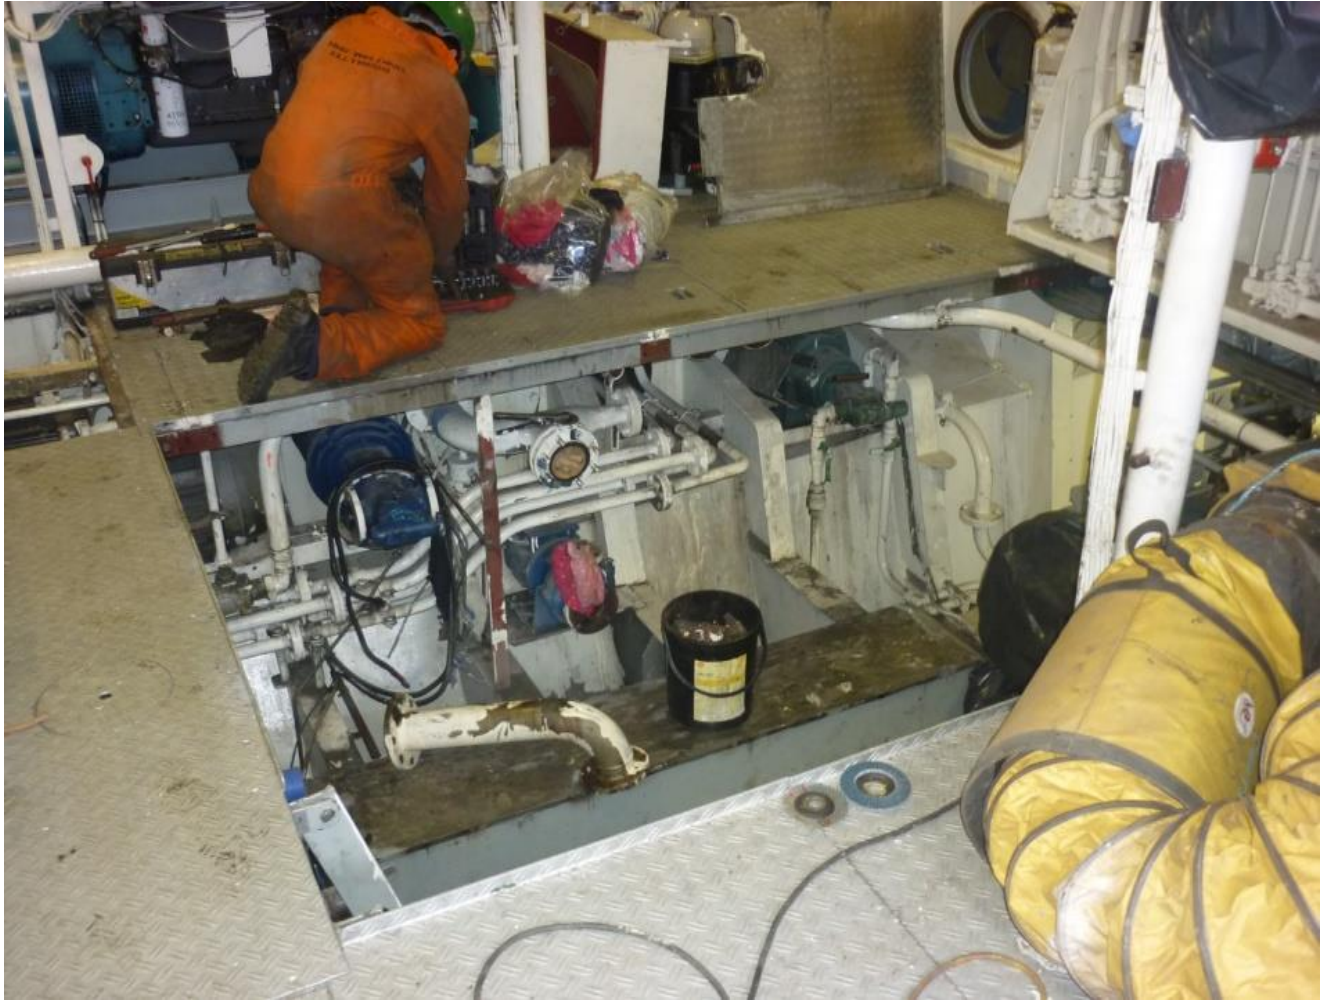
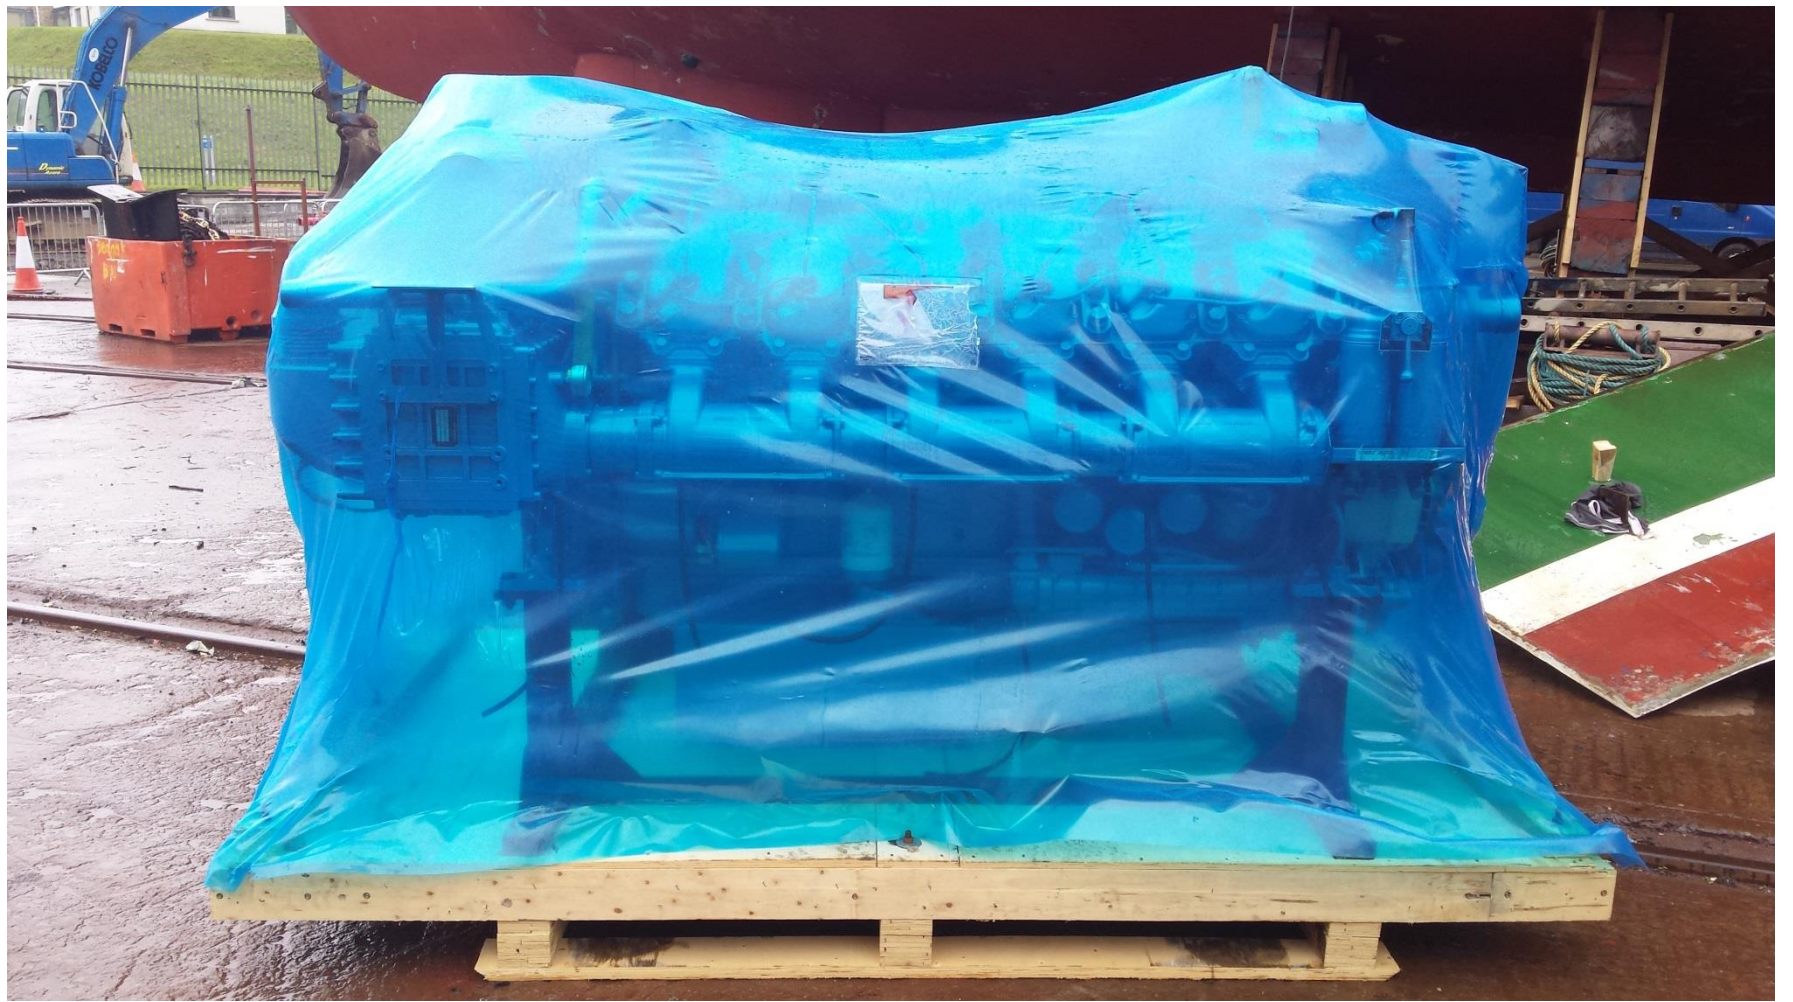
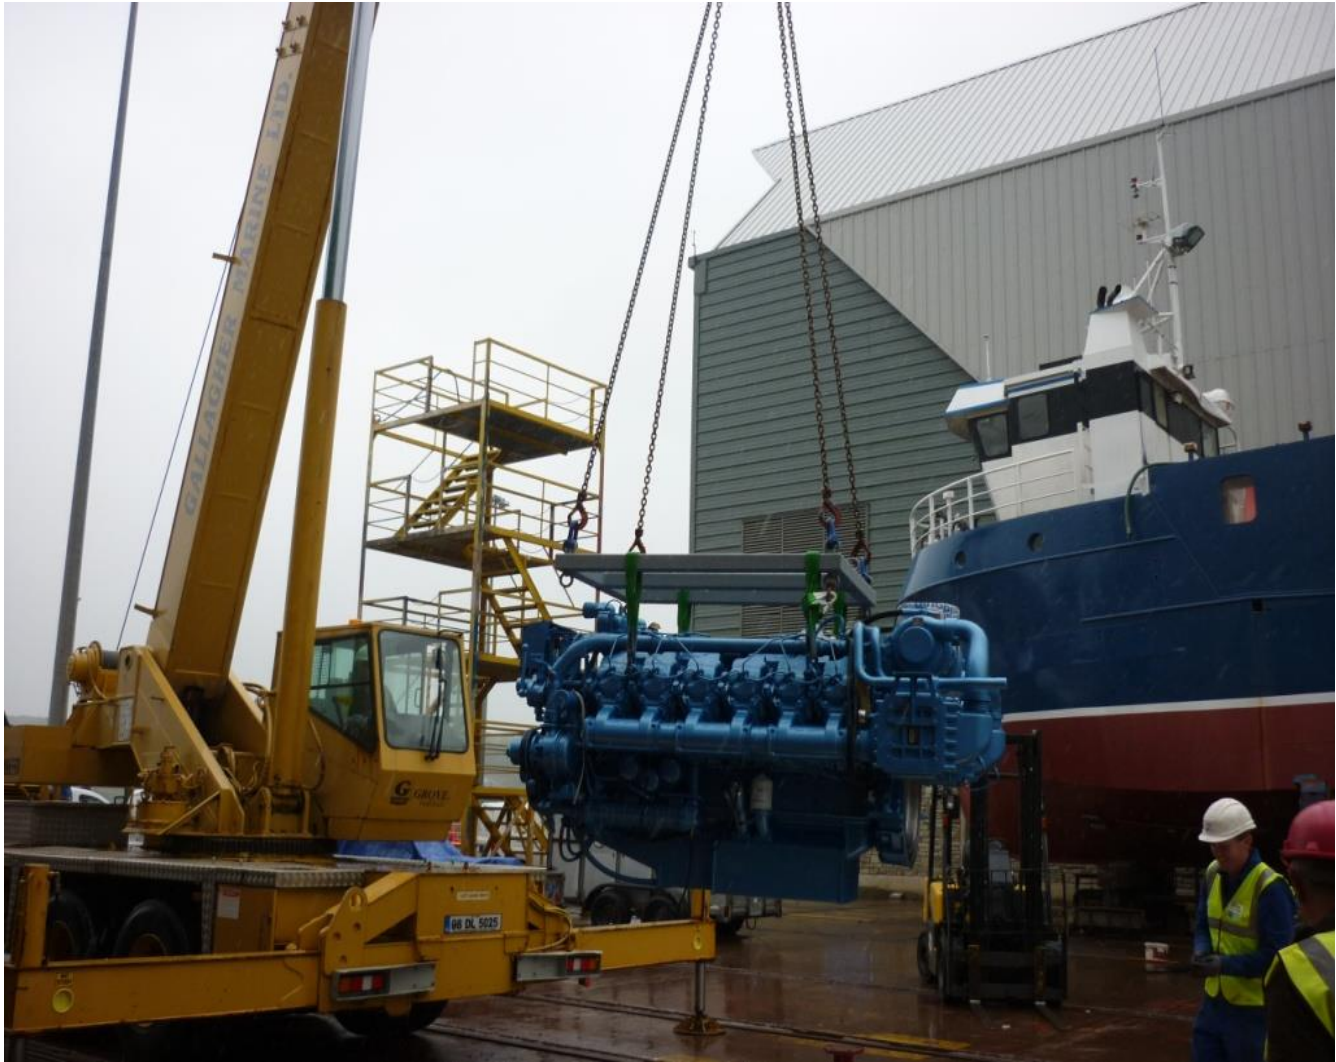
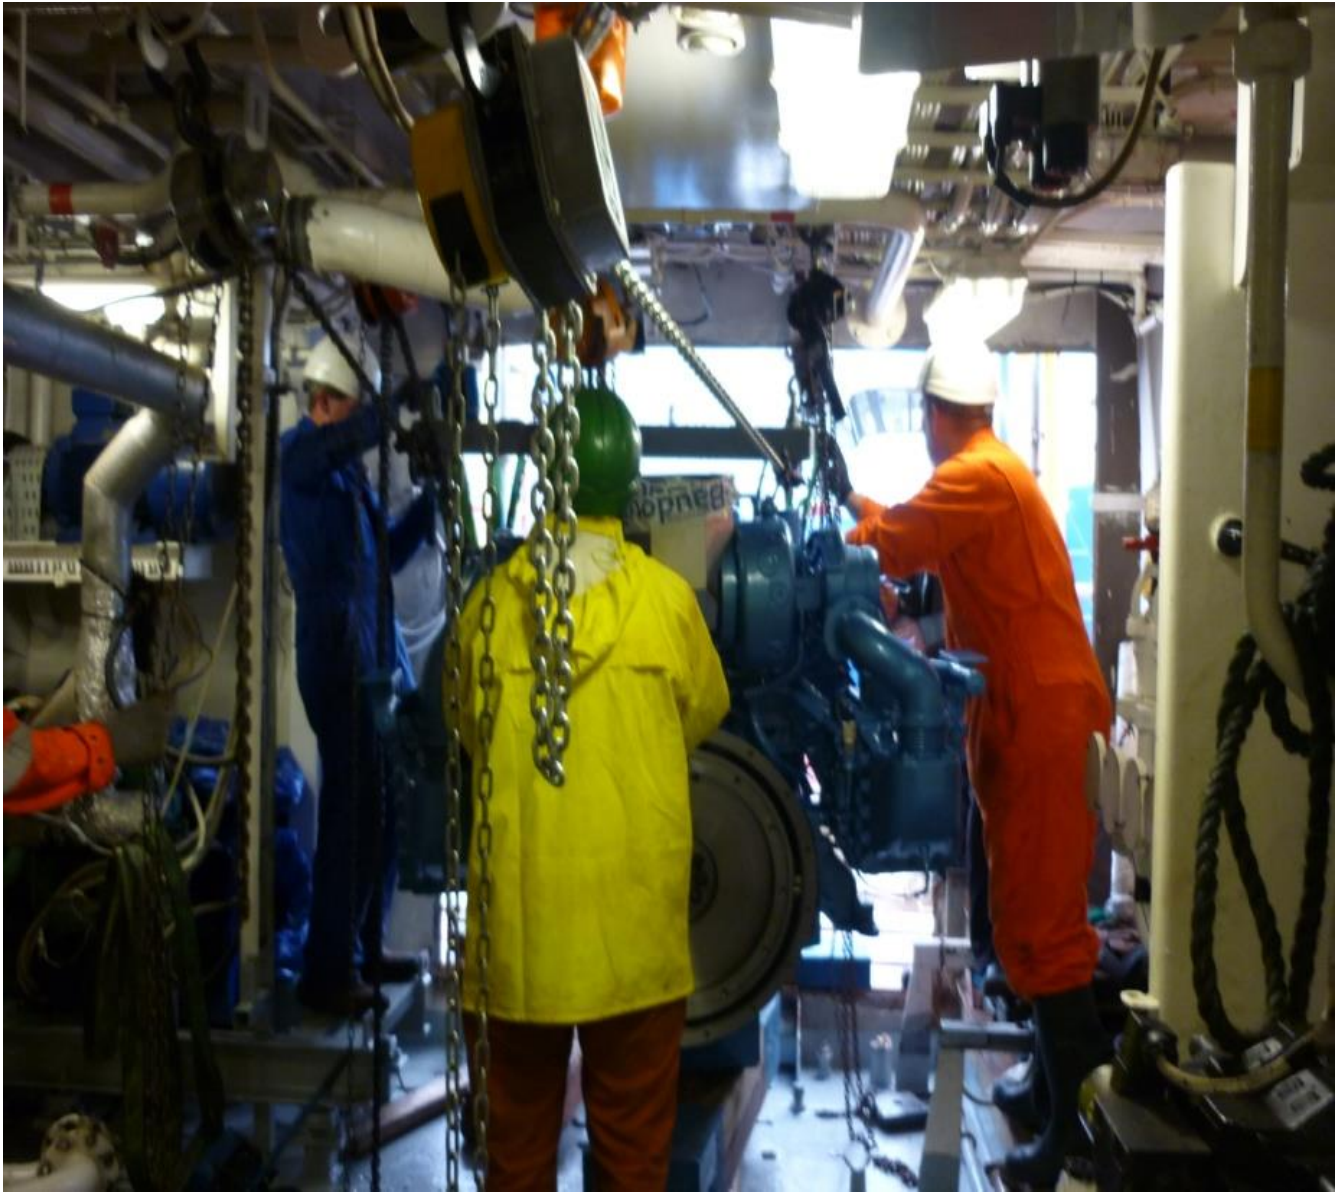
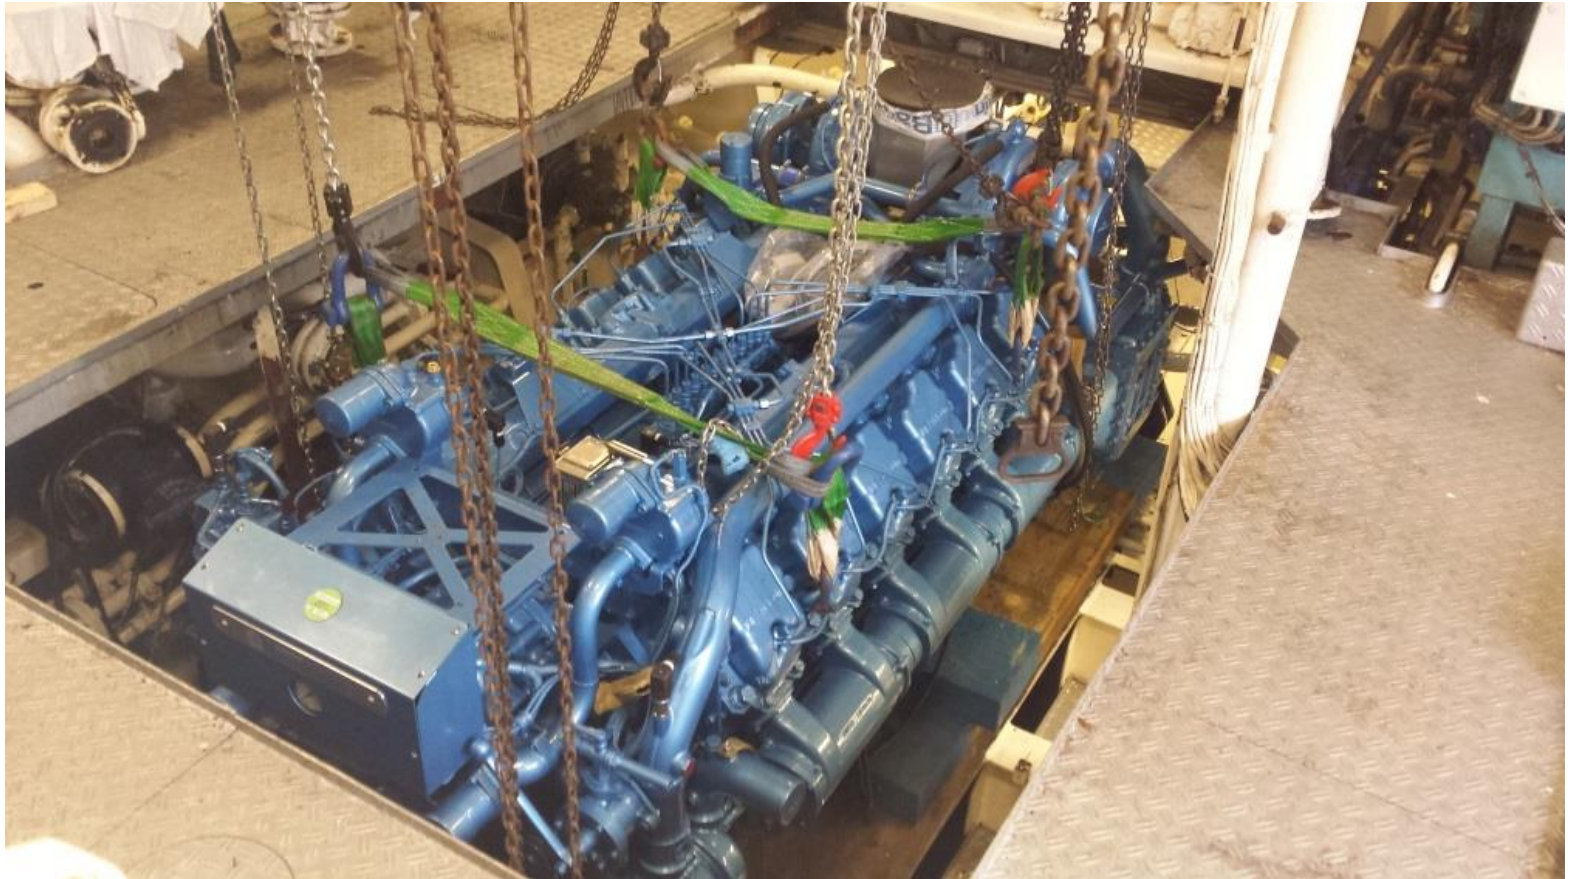
Drydock for engine replacement and refit

- Needed board approval for Emergency Dry Dock and procurement of new main engine
- Vessel had to be towed “dead ship” on the instructions of the Marine Survey Office
<https://www.youtube.com/watch?v=wGkqhdqDL0o>
- Towed to Dept of Marine synchro lift and Yard in Killybegs Ireland
- 1st July vessel towed 2nd July alongside in Killybegs, work commences for hull cut
- 10th July lifted out, hull cut, generators removed, way clear for engine
- 22nd Engine Factory acceptance test in Cassis
- Tue 28th July engine collected
- Thursday 30th July engine arrives
- Friday 31st July Engine lifted into place, hull closed
- 13th August Vessel refloated
- Engine started 18th August
- 21st August alignment and sea trials completed
- 22nd August sailed on survey, back in service
- 23rd August first oil change whilst en route to Survey ground!!
- 72 days from failure to new engine.....!!

Engine optimised for 1500RPM vs 1200 rpm on original requiring alterations

Vessel keel sump had to be cut to fit engine

Different cooling systems requiring new box coolers and extensive piping

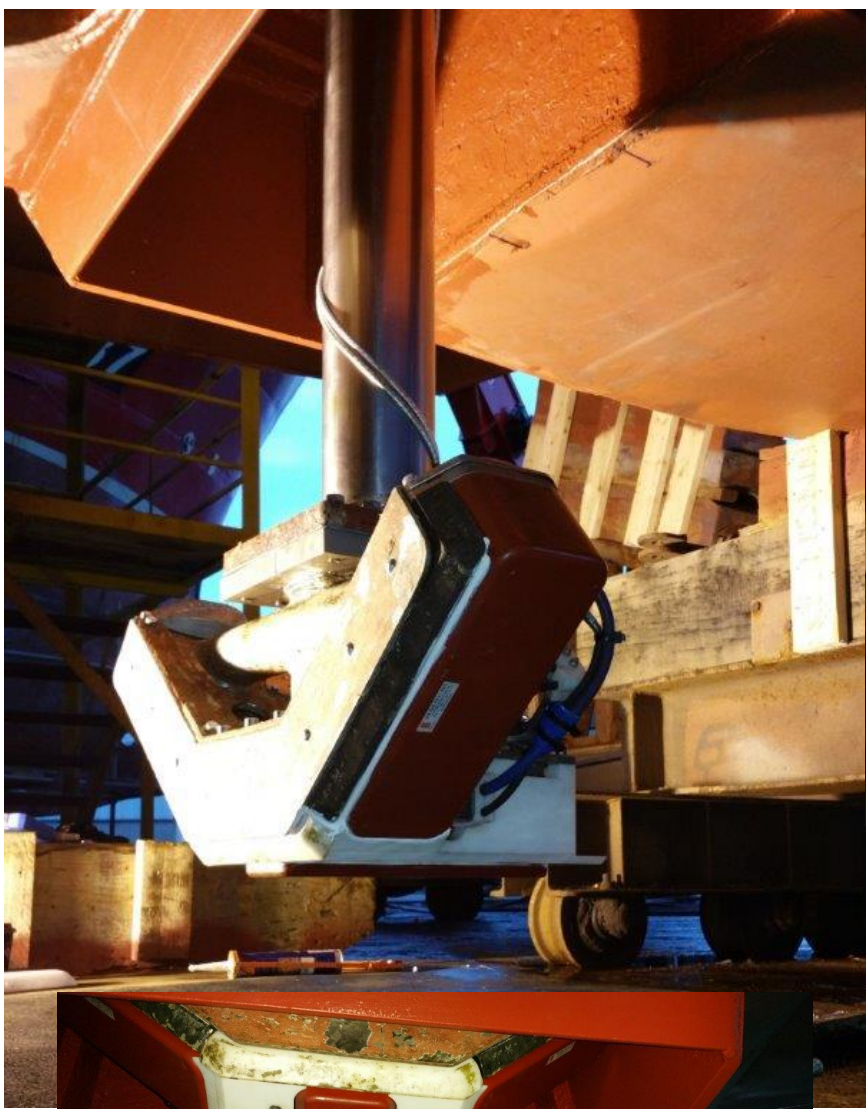
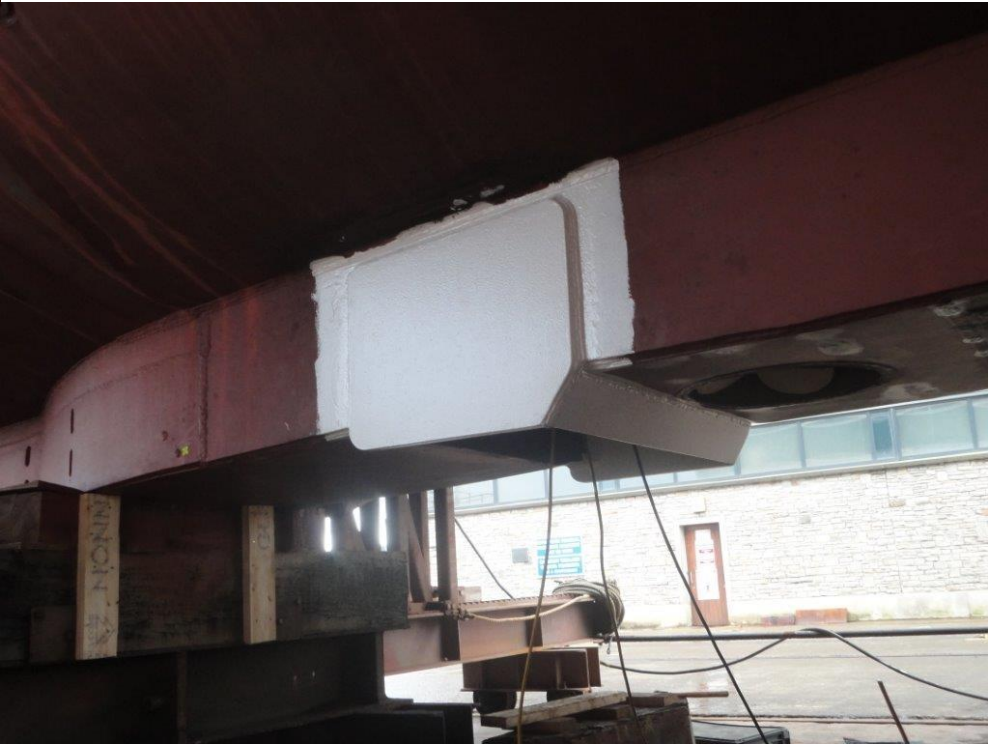
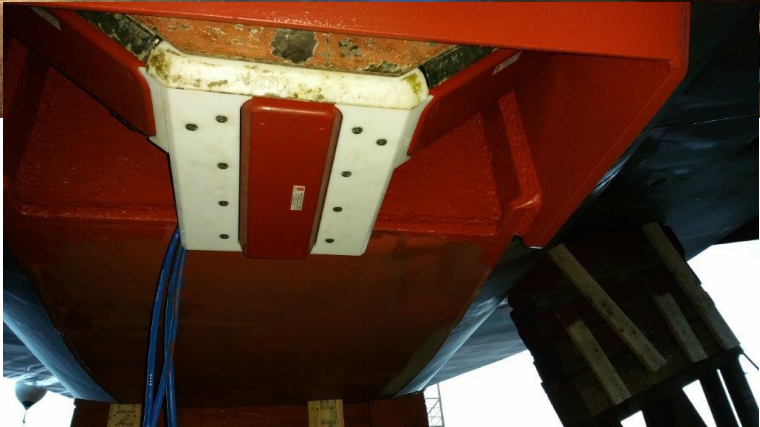
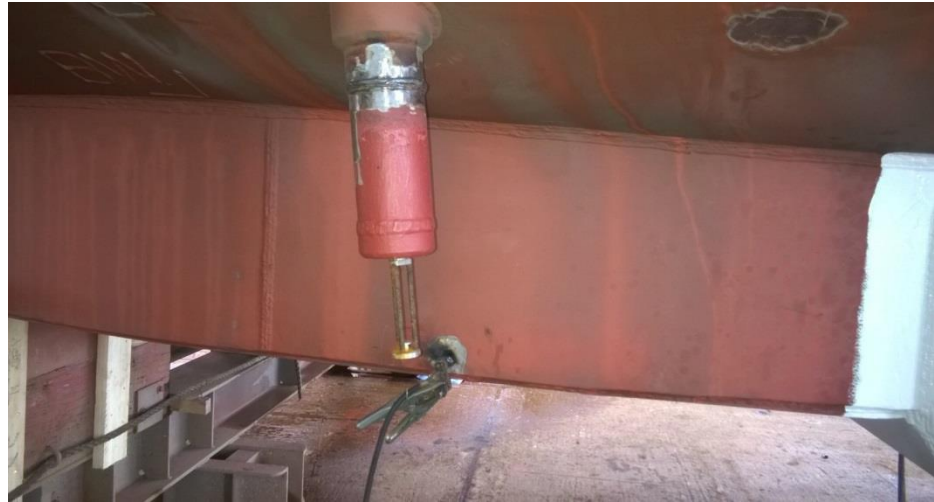
Additional work

- Ships anchor chain damaged new EM2040 Multibeam in May 2015
- Decision made to relocate EM2040 (1rx and 1 tx) on trial basis to replace redundant EM1002 on aft retraction unit during engine replacement work
- EM3002 reduced to single head unit and relocated in bow position
- Vessel Broadband system upgraded and bandwidth expanded
- System performing extremely well in this location
- Normal refit works such as antifouling, inspections , anodes completed
- Vessel sandblasted below the waterline whilst waiting for engine
- Full repaint completed
