Polar operational challenges and solutions

Operational Issues, challenges and solutions

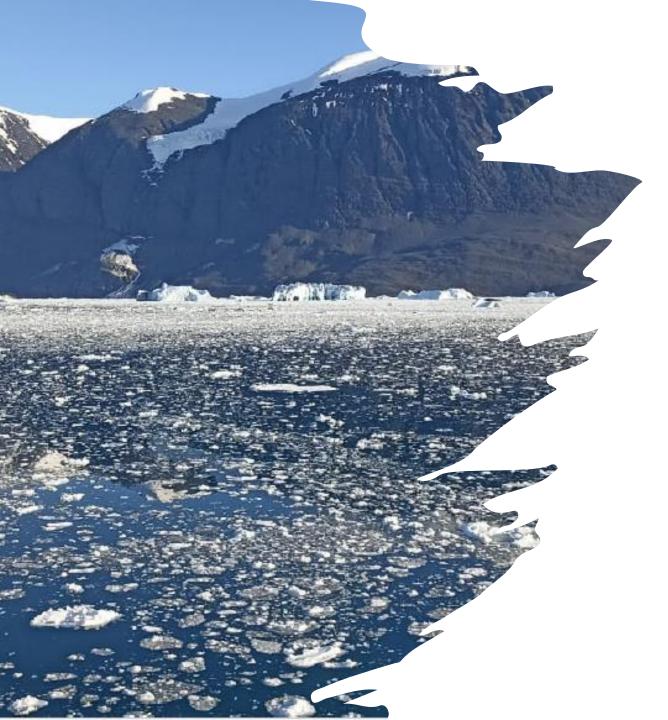
In the Survey Area, the availability of ECDIS Charts for the region of interest were either extremely limited or unavailable.

Paper charts available from the Danish Hydrographic office were originally compiled in the 1960s and come with accuracy warnings.

These are large scale, and the depths provided are spot depths. It is a common issue in these regions with vessels frequently encountering these situations

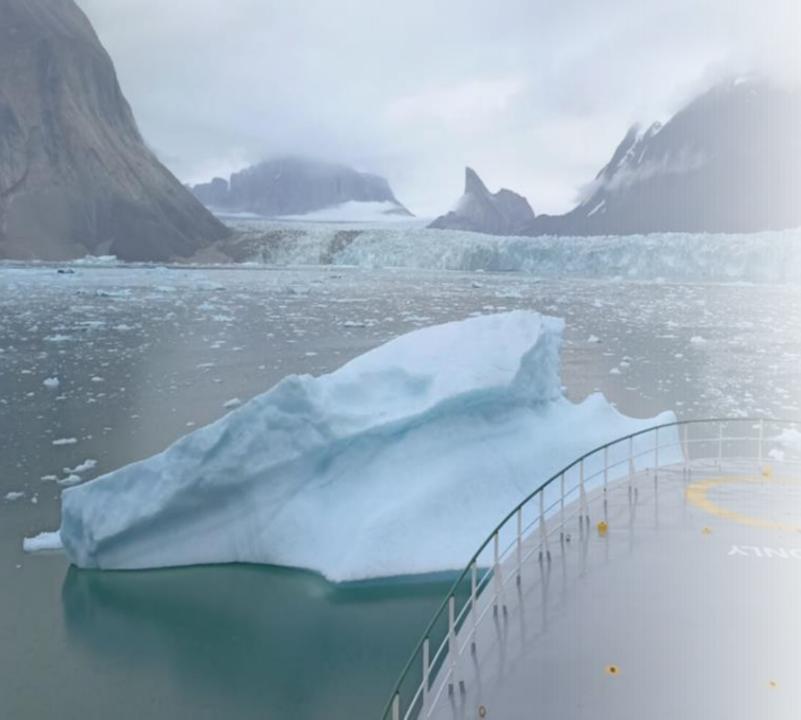
Under Polar Code the vessel uses risk-based procedures to ensure the vessel is kept safe and compliant with its status as a CAT C vessel as defined by the Polar Code.

The formal method used in the ships Polar Code Manual is the POLARIS Assessment System

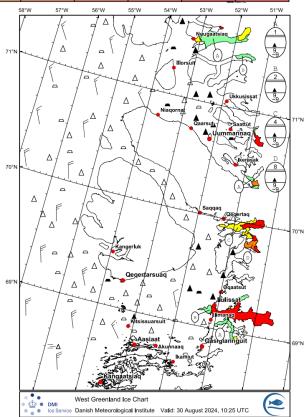
The Polaris System

Polaris (Polar Operational Limit Assessment Risk Indexing System) using the Egg Code format for assessing ice conditions.

Different Countries use slight variations of this system in their Ice Forecasts but in principle all are very similar.

Use of the egg code allowed for the vessel to calculate the Risk Index. As can be seen from the table, a CAT C vessel is restricted, accordingly awareness of the risk is vital

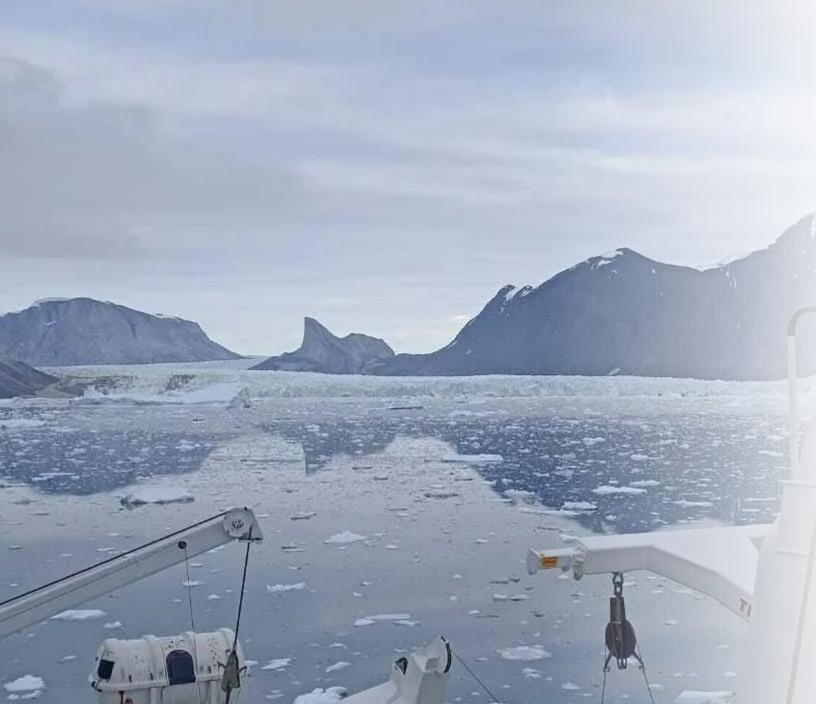
IcySea APP - An ice information app for navigation in polar regions providing various combined information in Polar Code complaint fashion.

Providing near real time sea ice information from various sources in interactive software that can be run on a low bandwith connection. This includes data from ice charts, satellite and radar imagery.

Various supporting information and descriptions and application can be tailored to vessel's ice class.

Celtic Explorer used IcySea to supplement the approved systems on board.

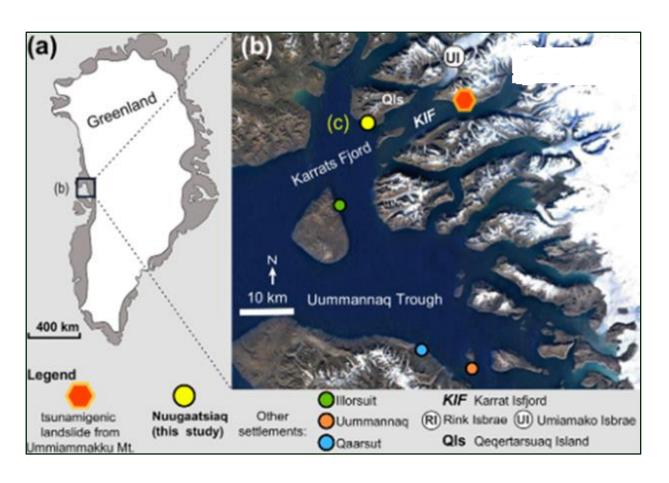
Image – International Tsunami Information Centre.

(a) Location of fjord (b) General position of Karrat Fjord in western Greenland. Nuugaatsiaq shown in yellow

On 17 June 2017, a significant tsunami occurred in the Karrat Fjord, resulting in severe property damage and casualties in the fishing village of Nuugaatsiaq.

The seismic energy detected prior to the tsunami was so significant it was first thought to have been the result of a magnitude 4.1 earthquake.

However, the cause was a landslide on a steep slope of the fjord where a significant amount of rock plunged into the water below, 32 kilometers northeast of the village. Forty-five structures, including eleven houses, were washed away or destroyed, and four people were killed.

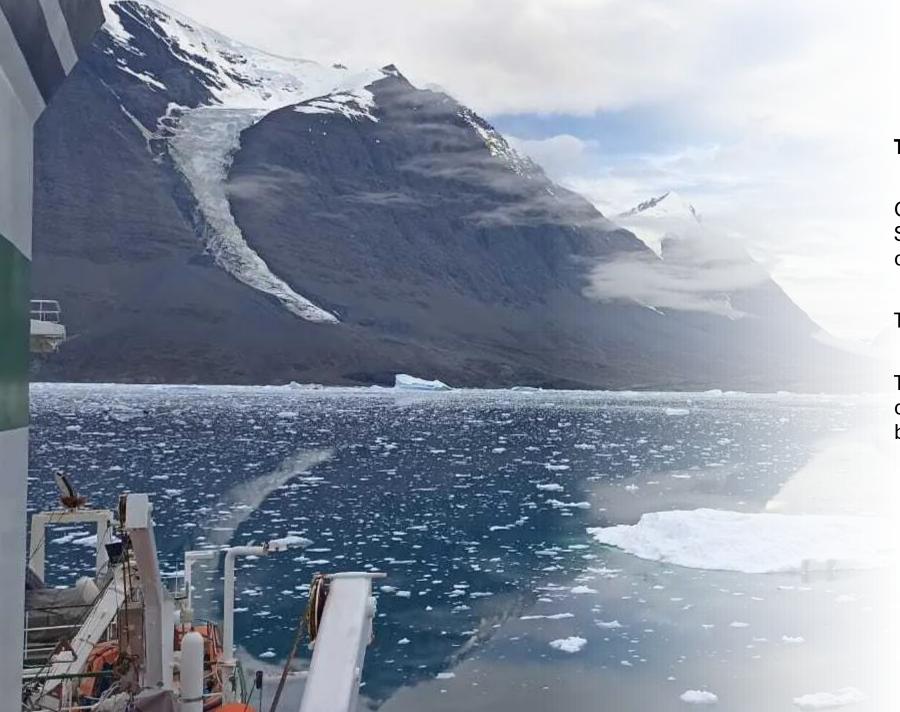
Greenland publish a monthly Situation Assessment on the risk of further landsides in the region.

The fjord is monitored by CCTV.

The information was available online which allowed the ship to be aware of current risks.

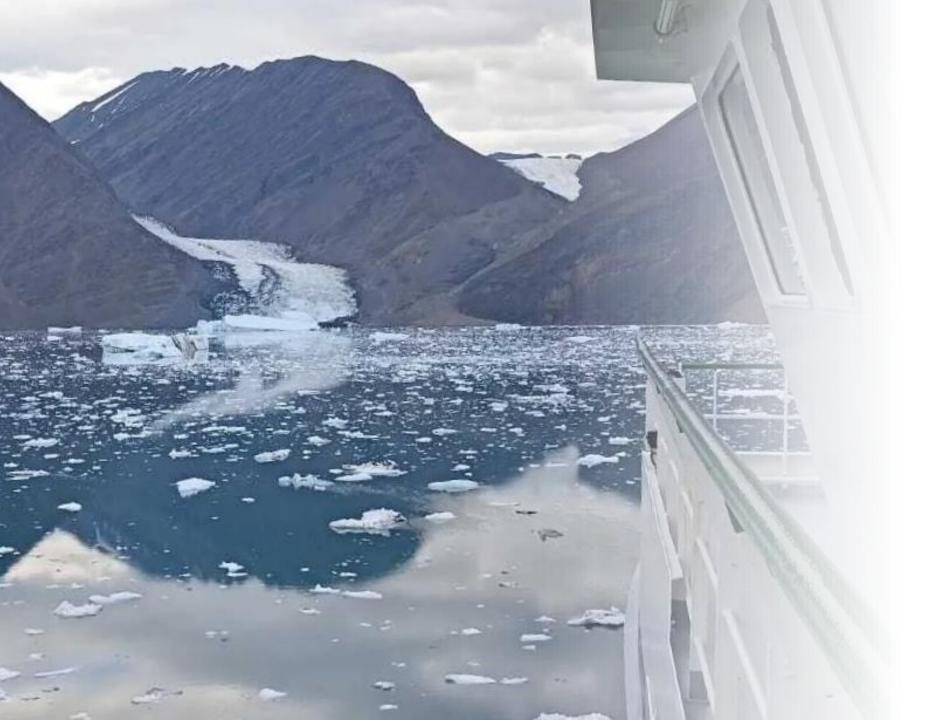
Conventional Satellite overage was going to be a challenge due the low elevation of those Satellites at the high latitude combined with the subject Fjords being surrounded by mountains with heights reaching 2000M +.

Alternative services installed on the vessel, however, as untested it was of concern. Nevertheless, Starlink for example provided excellent coverage for the duration of the Survey.
