RV Odon De Buen: Sea trials in Antarctica

MAIN (PLATFORM TESTING)

TEST ATLANTIC NAVIGATION CONDITIONS

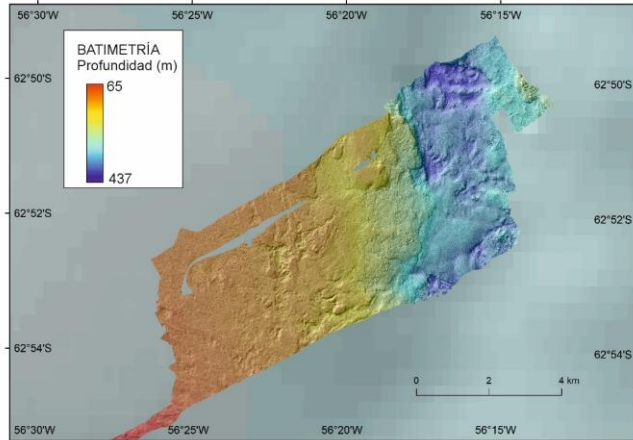
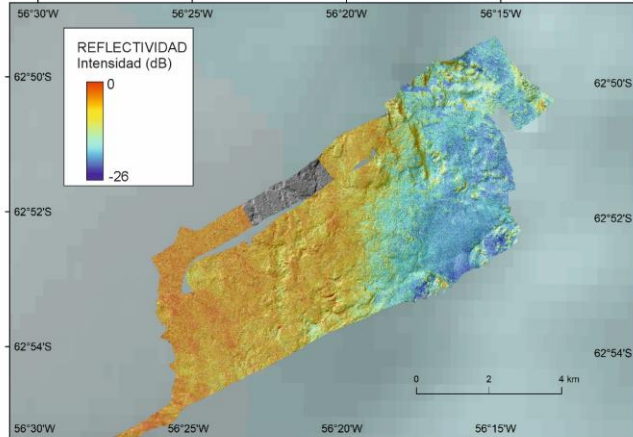
Multibeam Echosounders

- Functionality check of EM712 and EM124 (Kongsberg), and the SBP function of the EM124
- Mainly using the EM712 due to the depth of the work area
- Synchronized through the K-Sync synchronization unit
- Sound velocity profile measured with the AML Valeport profiler, which was integrated into the processing using the CARIS HIPS and SIPS software

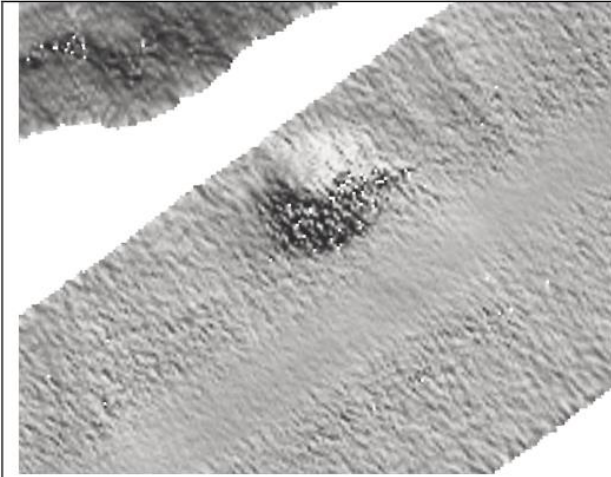
Datos adquiridos con la ecosonda Hydrosweep DS, B/O Sarmiento de Gamboa

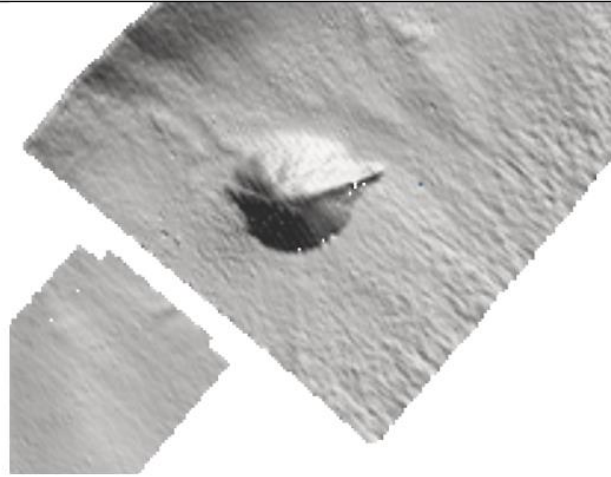
Datos adquiridos con la ecosonda EM124, B/O Odón de Buen

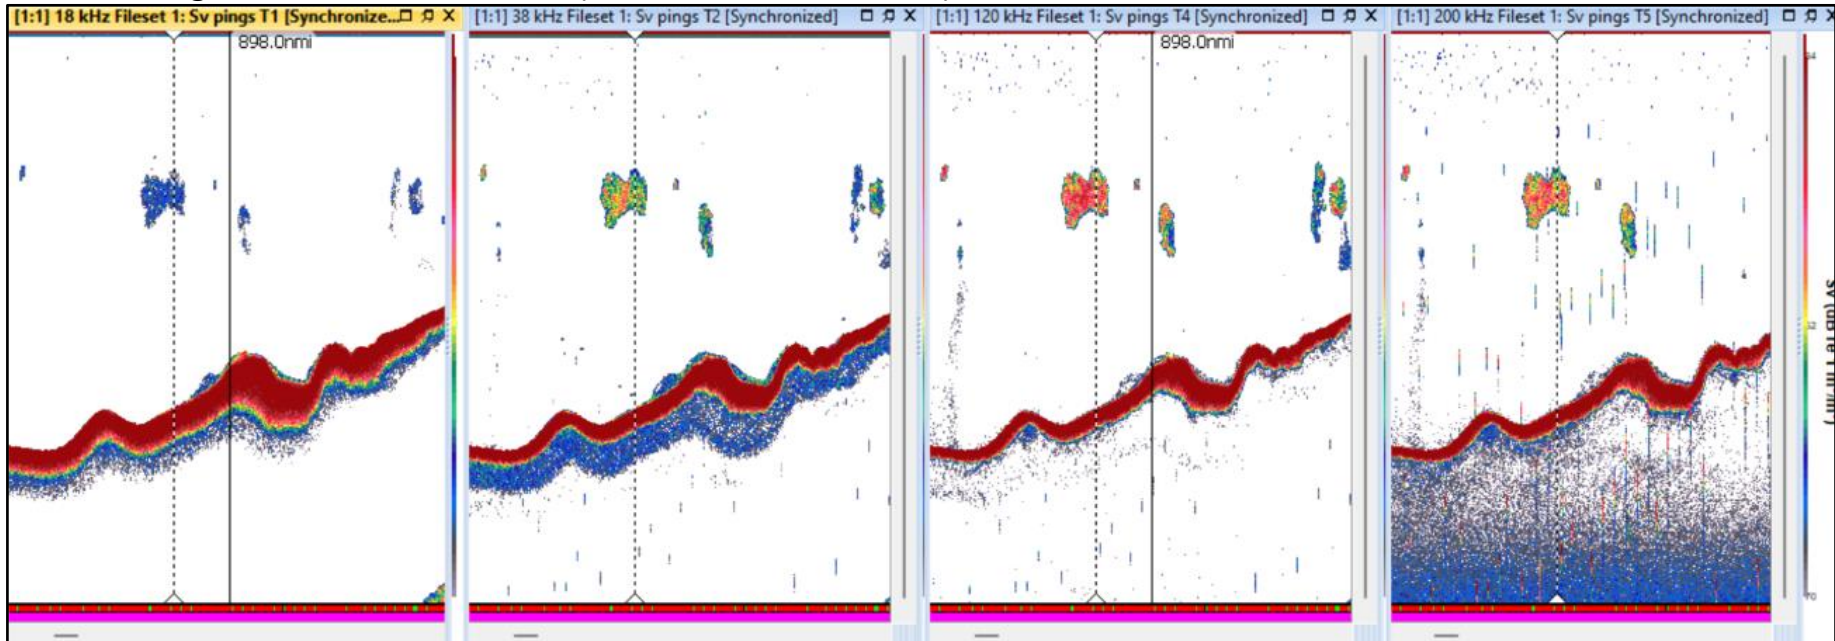
Biological Acoustics

The primary frequency was successfully adjusted, but it was not possible to obtain a quality echogram with the parametric system, as neither the seafloor nor the processed signal could be detected.

EK80 and EM70 echosounders have been tested.

High data storage requirements: EK80 data were recorded in Continuous Wave (CW) mode (narrowband, discrete frequencies) for 29.4 hours, consuming 373 GB. With the EM70 multibeam echosounder, 42 minutes of recording (single sector) consumed 1 GB.

- EM70 test
- High storage requirements

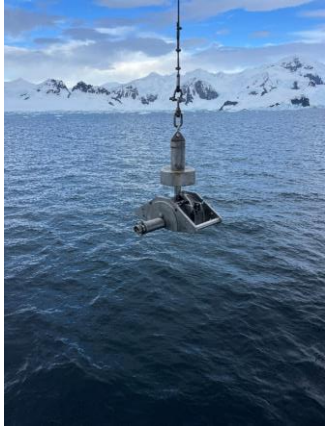
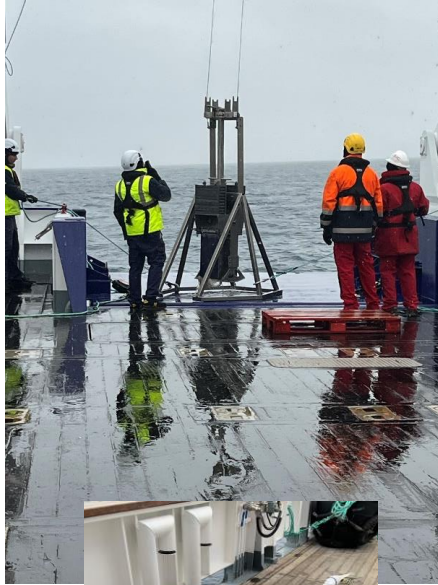
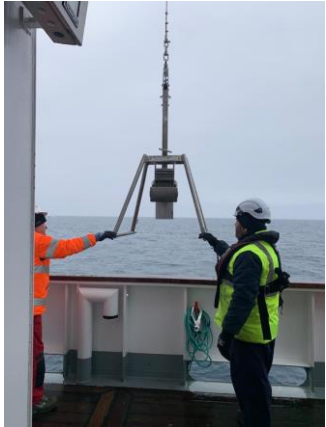
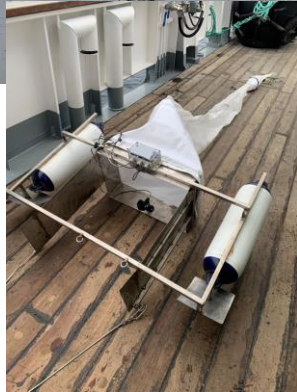
Sampling and Nesuton

- 2 BOX-CORER & DRAGA Shipeck, Manta Trawl.
 - A-frame
 - T-frame
-
- No problems with the T-Frame
 - With the multipurpose winch (adding an intermediate block, calibrating the winch)
 - Improvement of the sample sorting area (drainage, proximity to water intake)

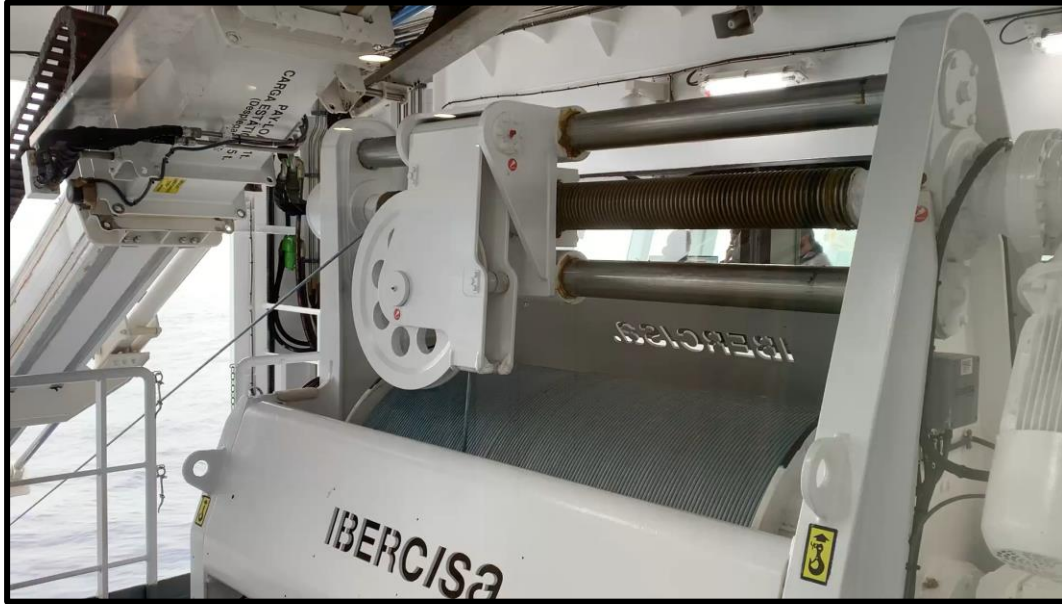
Active Heave Compensation (AHC) on winches

- Good heave compensation (waves of 3 m, crosswise to the sea. Stabilization +/- 10 cm)
- Tested with ROVT & CTD

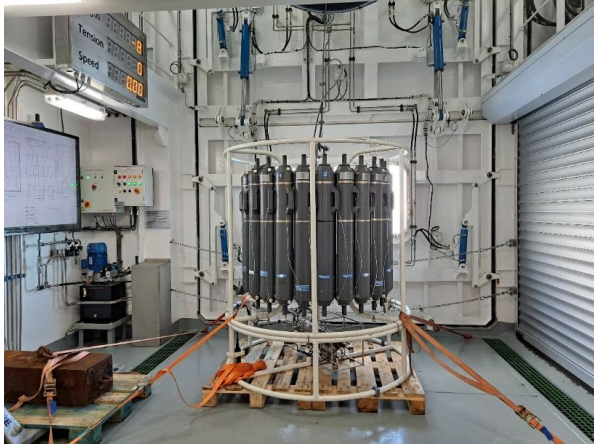
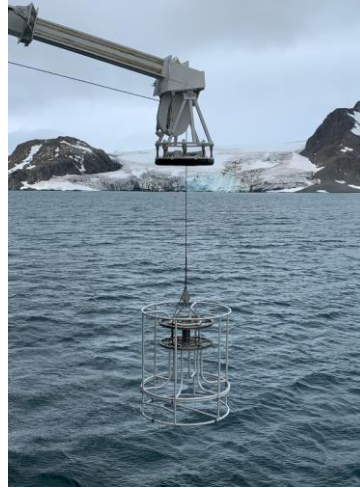
- SBE 911+ CTD with 24 bottles carousel with auxiliary sensors
- 4 casts in different locations
- CTD hangar ok (dimensions / operation)
- Winch control area some changes proposed
- CTD winch controls complex but safe and reliable
